**Reconnaissance-Level
Geologic Hazard Assessment Report**

Proposed Development
Business Boys, LLC's Property
North of Sacchi Beach, Coos County, Oregon

Coos County Property ID:
T26S-R14W-S32-TL403

June 24, 2024

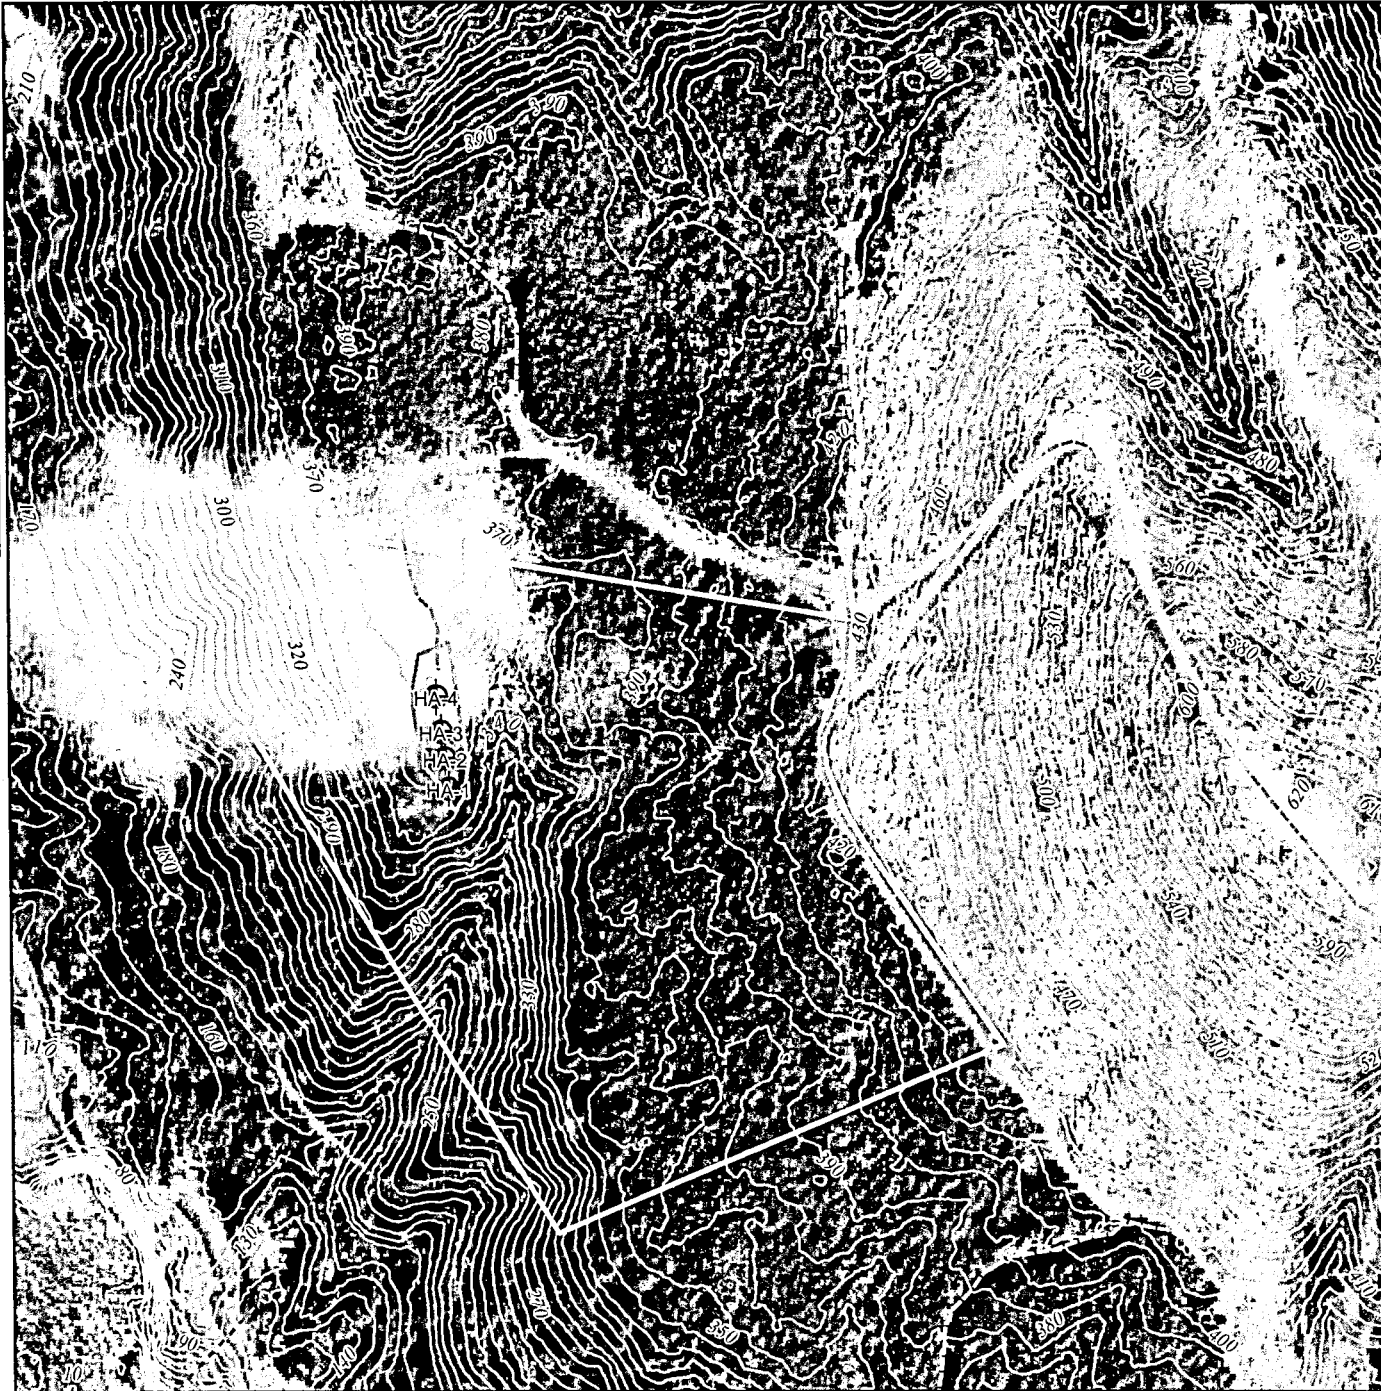
FIGURE 4
EXISTING SITE PLAN

The subject property is situated on a west-facing slope except for the center of the property which encompasses a relatively small drainage basin (see Figure 4). A gravel access road runs along the eastern property boundary. A dirt access road forks just above the northeast corner of the property boundary and continues northwest across tax lot 300 and then turns to enter the site at the center of the north property line (see Figure 5). At the north end of the cleared area, the proposed development area slopes gently towards the south. To the east and west of the cleared area, the property slopes moderately; however, to the southeast, the property slopes steeply into the drainage ravine (see Figures 5).

Before our site investigation the proposed developable area was cleared of trees and brush (see Figures 4 and 5). After clearing, the top of the terrace feature was left ungraded and slopes with the natural gradient of the terrace to the west, south, and east. (see Figures 5). At the time of our site visit, the cleared area was abundant with slash piles, organic debris, and other deleterious material.

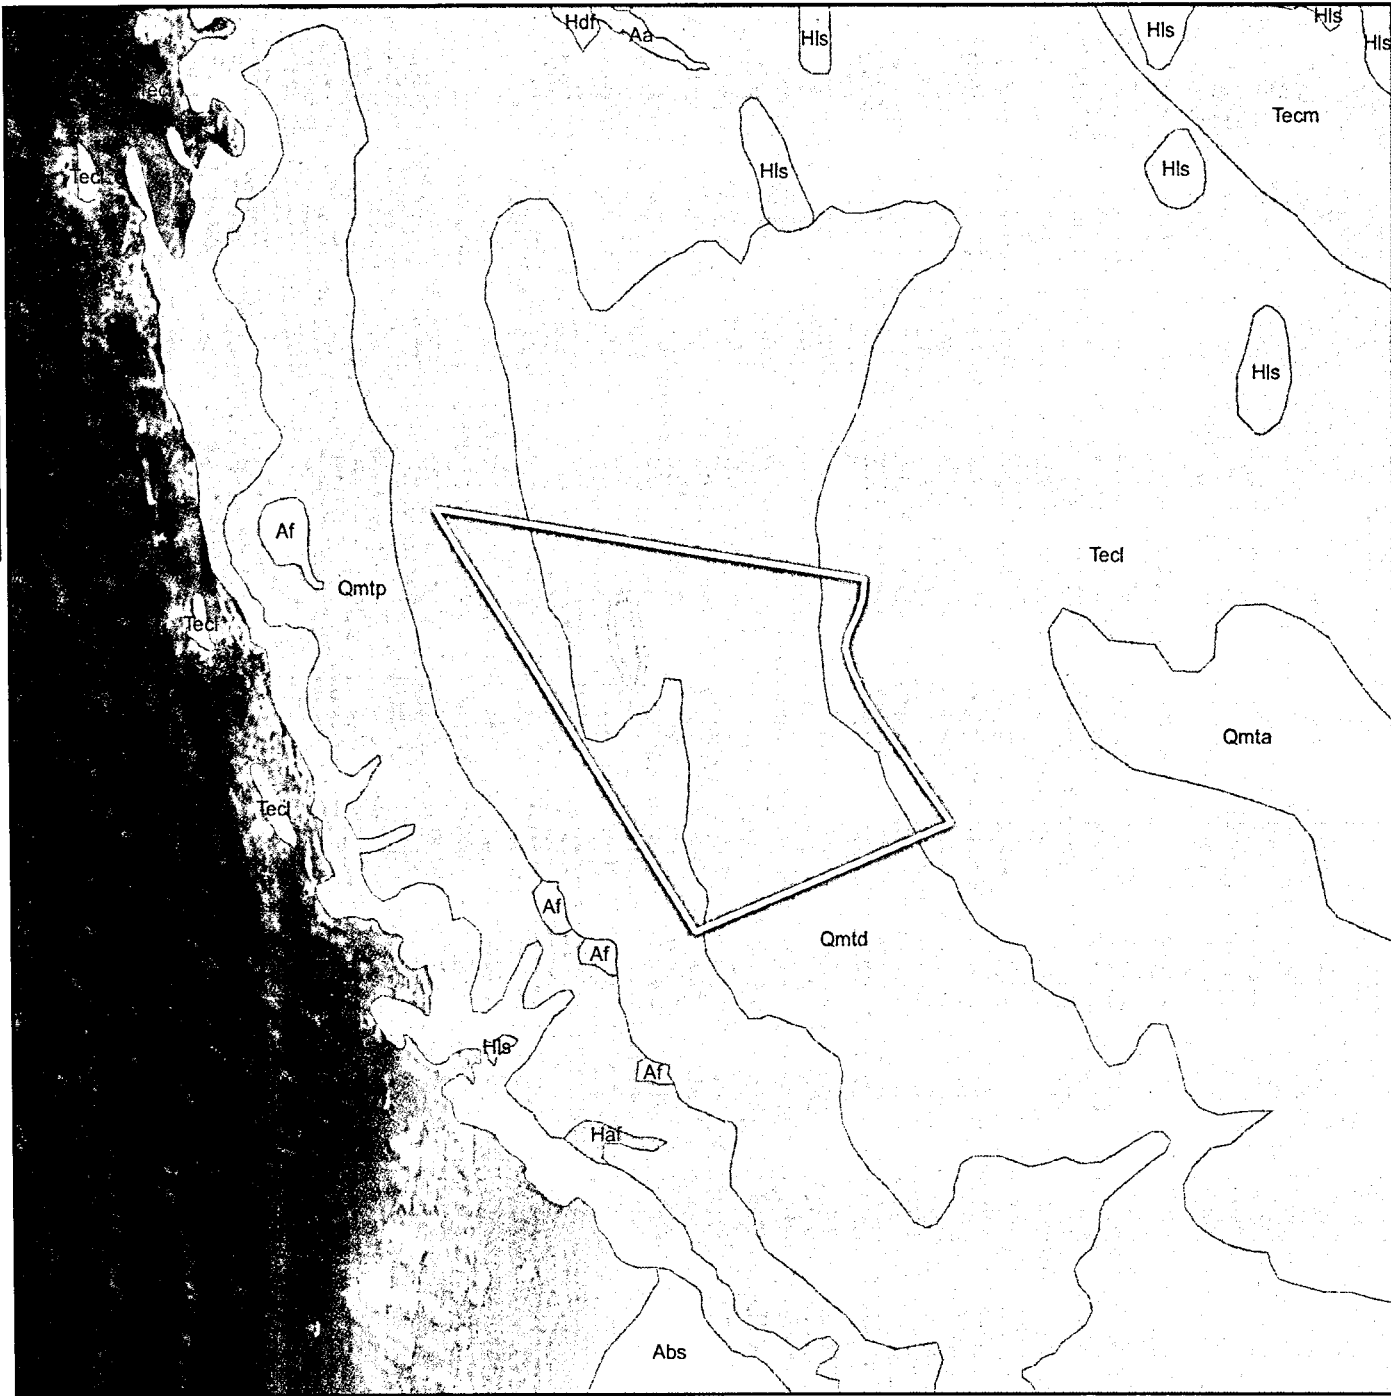
Site Geology: The Seven Devils marine terrace mantles most of the property and encompasses the cleared area for future development (see Figure 6). The remainder of the property is mapped

The Sevens Devils terrace is relatively flat lying and is situated mostly on the higher elevated portion of the property. The deposits typically consist of unconsolidated to slightly cemented sand and gravel that were deposited in a shoreline-beach environment. The underlying Coaleda formation is typically well-bedded micaceous siltstone, mudstone, and fine sandstone deposited in an ancient delta environment.

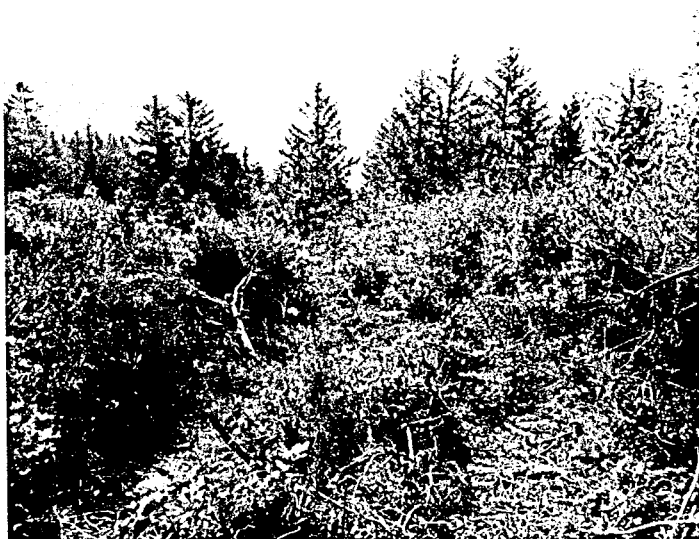
Looking south at top of slope at southern extent of cleared proposed buildable area.
