**Reconnaissance-Level
Geologic Hazard Assessment Report**

Proposed Development
Peppermill, LLC's Property
North of Sacchi Beach, Coos County, Oregon

June 24, 2024

Project No. 959-23013-01

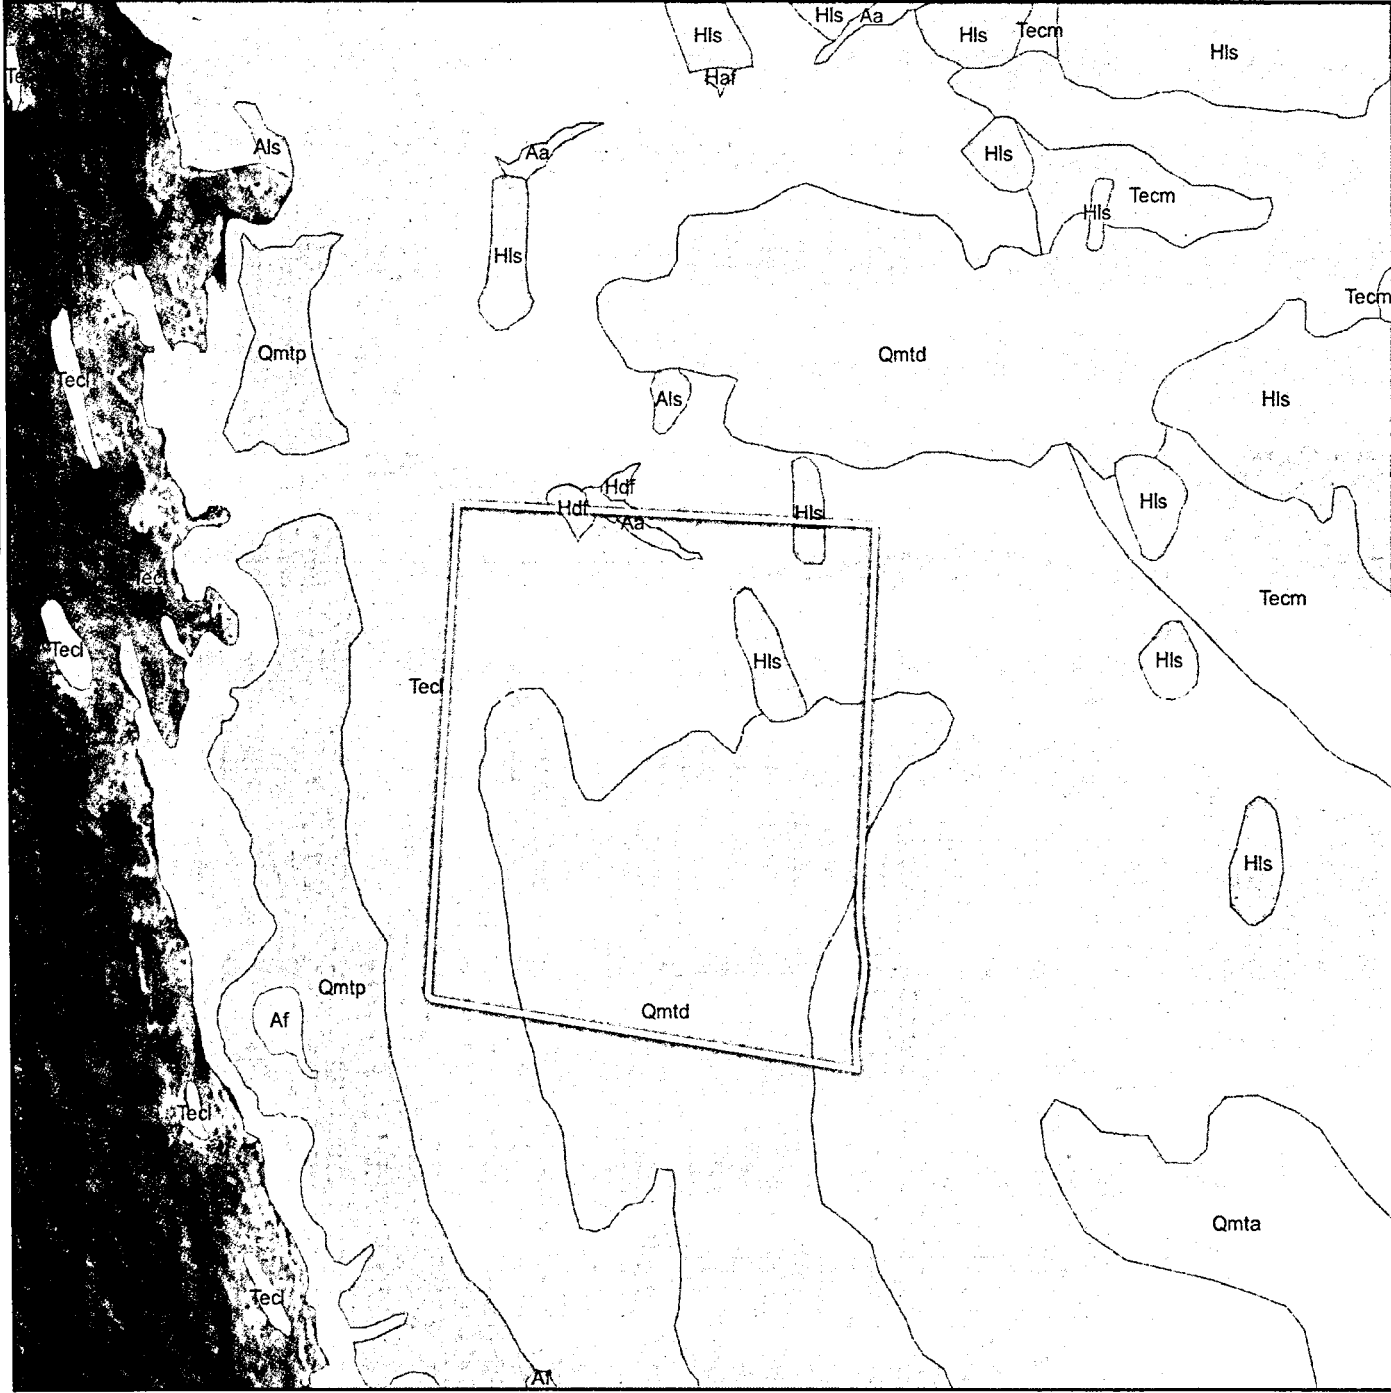
FIGURE 6
GEOLOGY MAP
 PEPPERMILL, LLC'S PROPERTY
 NORTH OF SACCHI BEACH
 BANDON, OREGON

Site Geology: The Seven Devils marine terrace mantles the southern half of the property and encompasses the top of the cleared western ridge (see Figure 6). The remainder of the property and northern portion of the western cleared ridge is mapped as the Eocene Coaledo formation. Small, isolated Holocene landslide and debris fan units are mapped in the northeast and at the

The DOGAMI landslide susceptibility map indicates that the landslide hazard is low to high with no very high areas mapped (see Figure 7). The geologic map of the property, however, shows that there are two small landslides in the northeast corner of the property and two small debris flow deposits along at the central part of the north property line along Mussell Creek (see Figure 6).

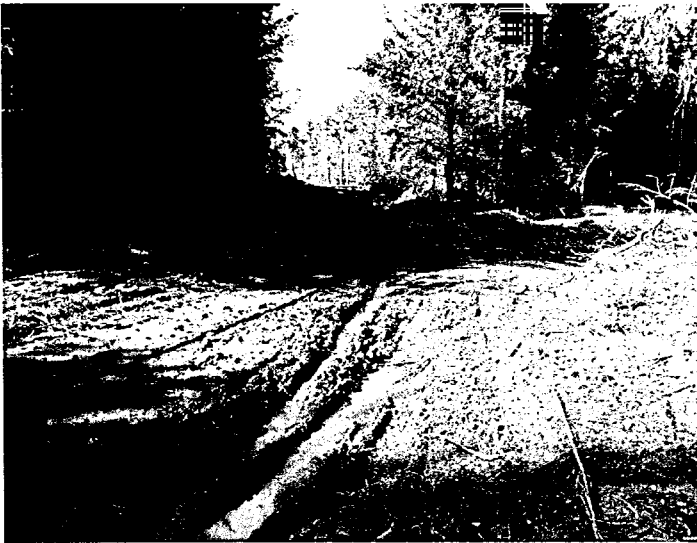
Looking west along dirt access road from southeast area of property.

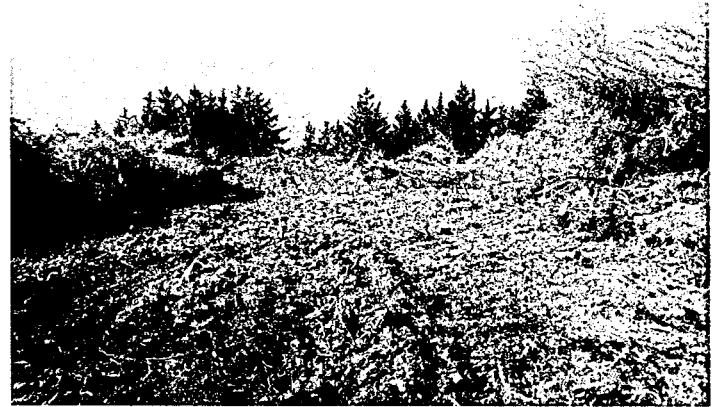
Looking west from the top of cleared proposed buildable area.

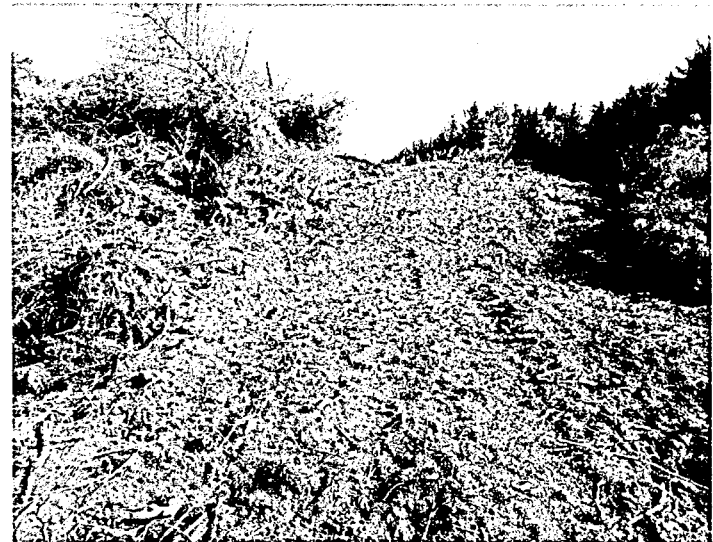
Looking east from bottom of western extent of cleared proposed buildable area.

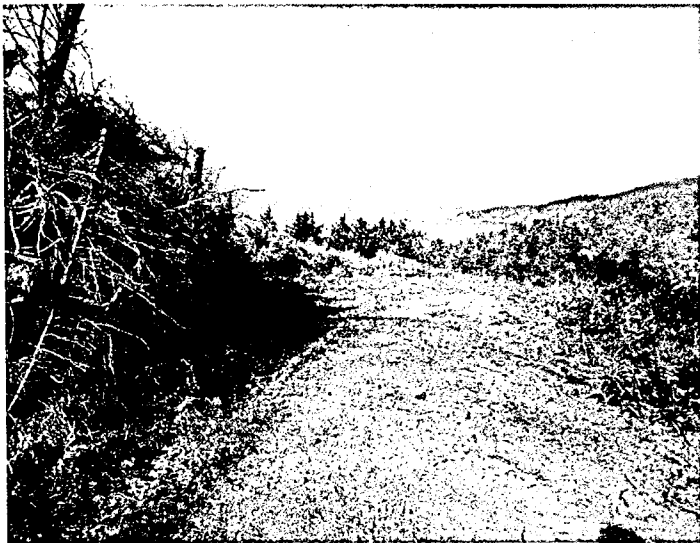
Looking north upslope of cleared proposed buildable area.

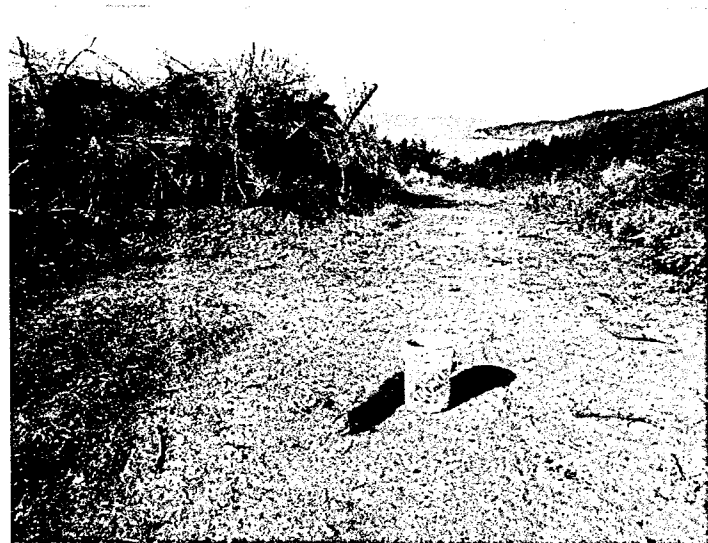
Hand Auger Boring HA-1 located at top of cleared proposed buildable area.

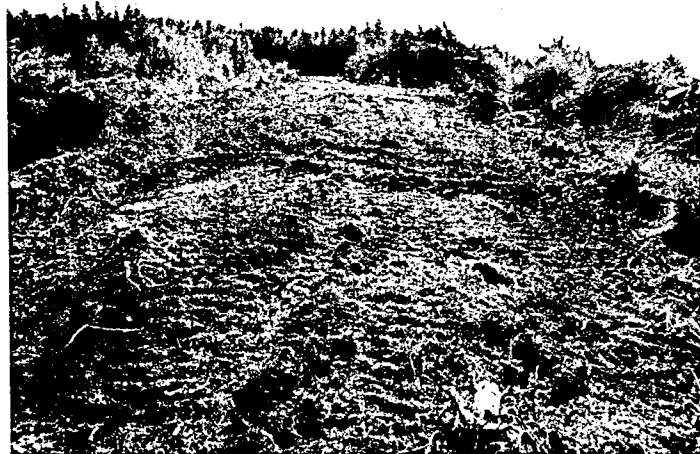
Looking south downslope of cleared proposed buildable area.

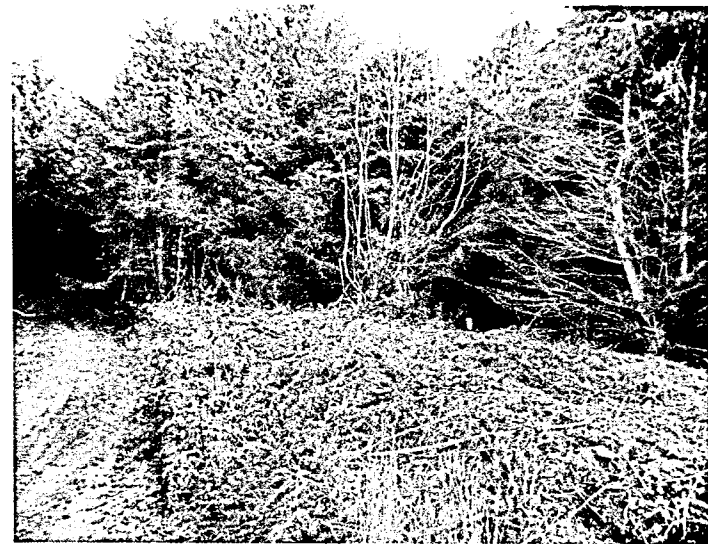
HA-2 located at southern extent of cleared proposed buildable area.

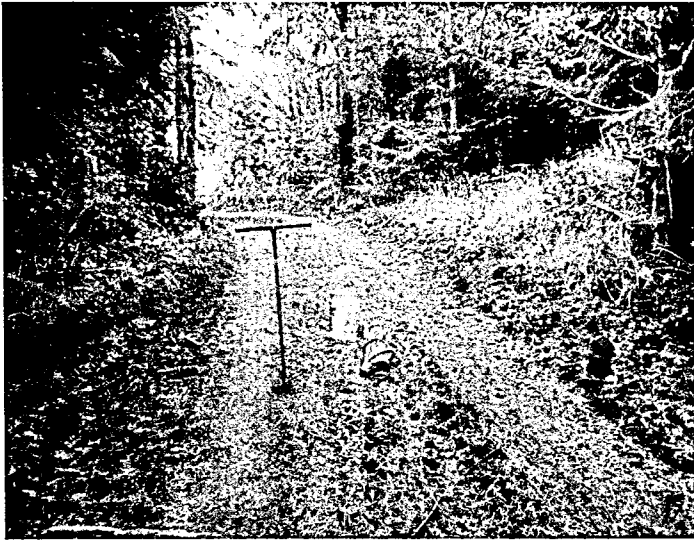
HA-3 located at access road 30 feet east of cleared proposed buildable area.

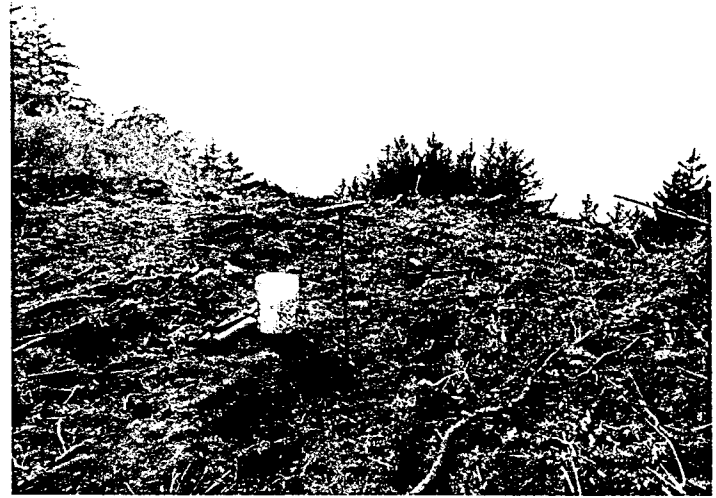
HA-2 looking west approximately 15 feet east from top of slope.

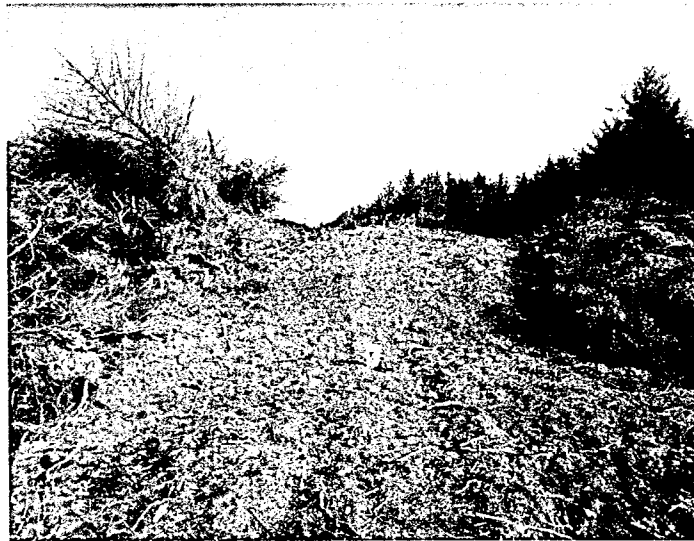
HA-4 located at western extent of cleared proposed buildable area.

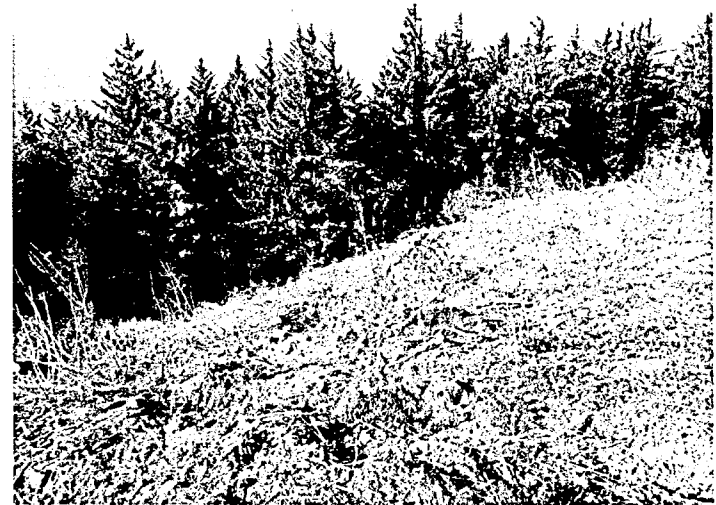
Looking northwest at logged hillside from western extent of cleared proposed buildable area.
