February 16, 2022

Daniel Platt
68 School Street
Hingham, MA 02043

**Subject: Geohazard & Geotechnical Review
Lot 1801 - St. Andrews Lane – Bandon, Oregon
GCN/True North Project 1592/22-0065**

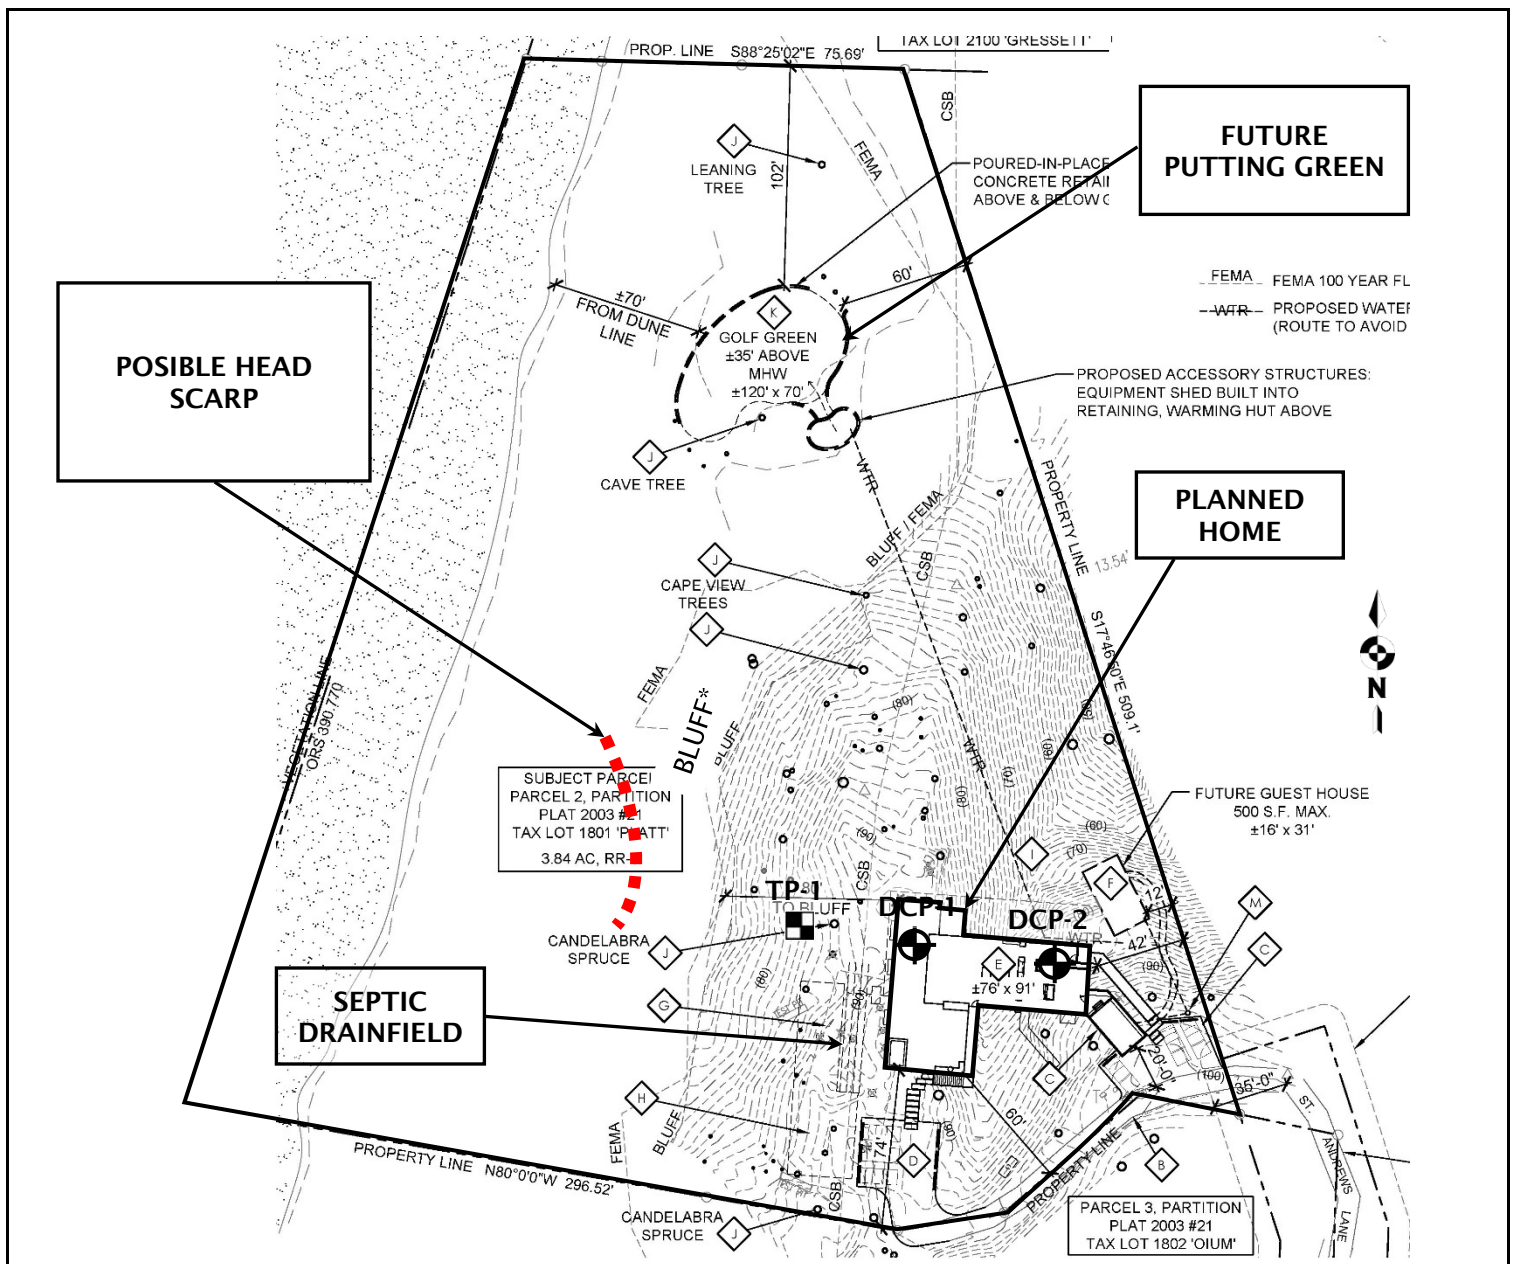
<p>PROJECT 1592</p>	<p>PLATT RESIDENCE AGATE LANE - BANDON</p>	
<p>2839 SE Milwaukie Avenue Portland, OR 97202</p>	<p>JAN 2022 Drawn By: tac</p>	<p>SITE LAYOUT & EXPLORATIONS</p>	<p>FIGURE 2</p>

Dodge Surveying and Planning produced a survey of the eastern side of the site. Dodge labeled the "BLUFF/FEMA" line shown in Figure 2 to identify a distinct break in the slope. The areas downslope and west of the of the break were not surveyed. The descriptions below are based on the survey data provided by Dodge.

We investigated subsurface conditions of the site on September 22, 2021, with two DCP tests, designed DCP-1 and DCP-2, to refusal depths of up to 13 feet below ground surface (bgs) on September 22, 2021. The approximate locations of the DCPs are shown on Figure 2. DCP logs are provided in Attachment A.

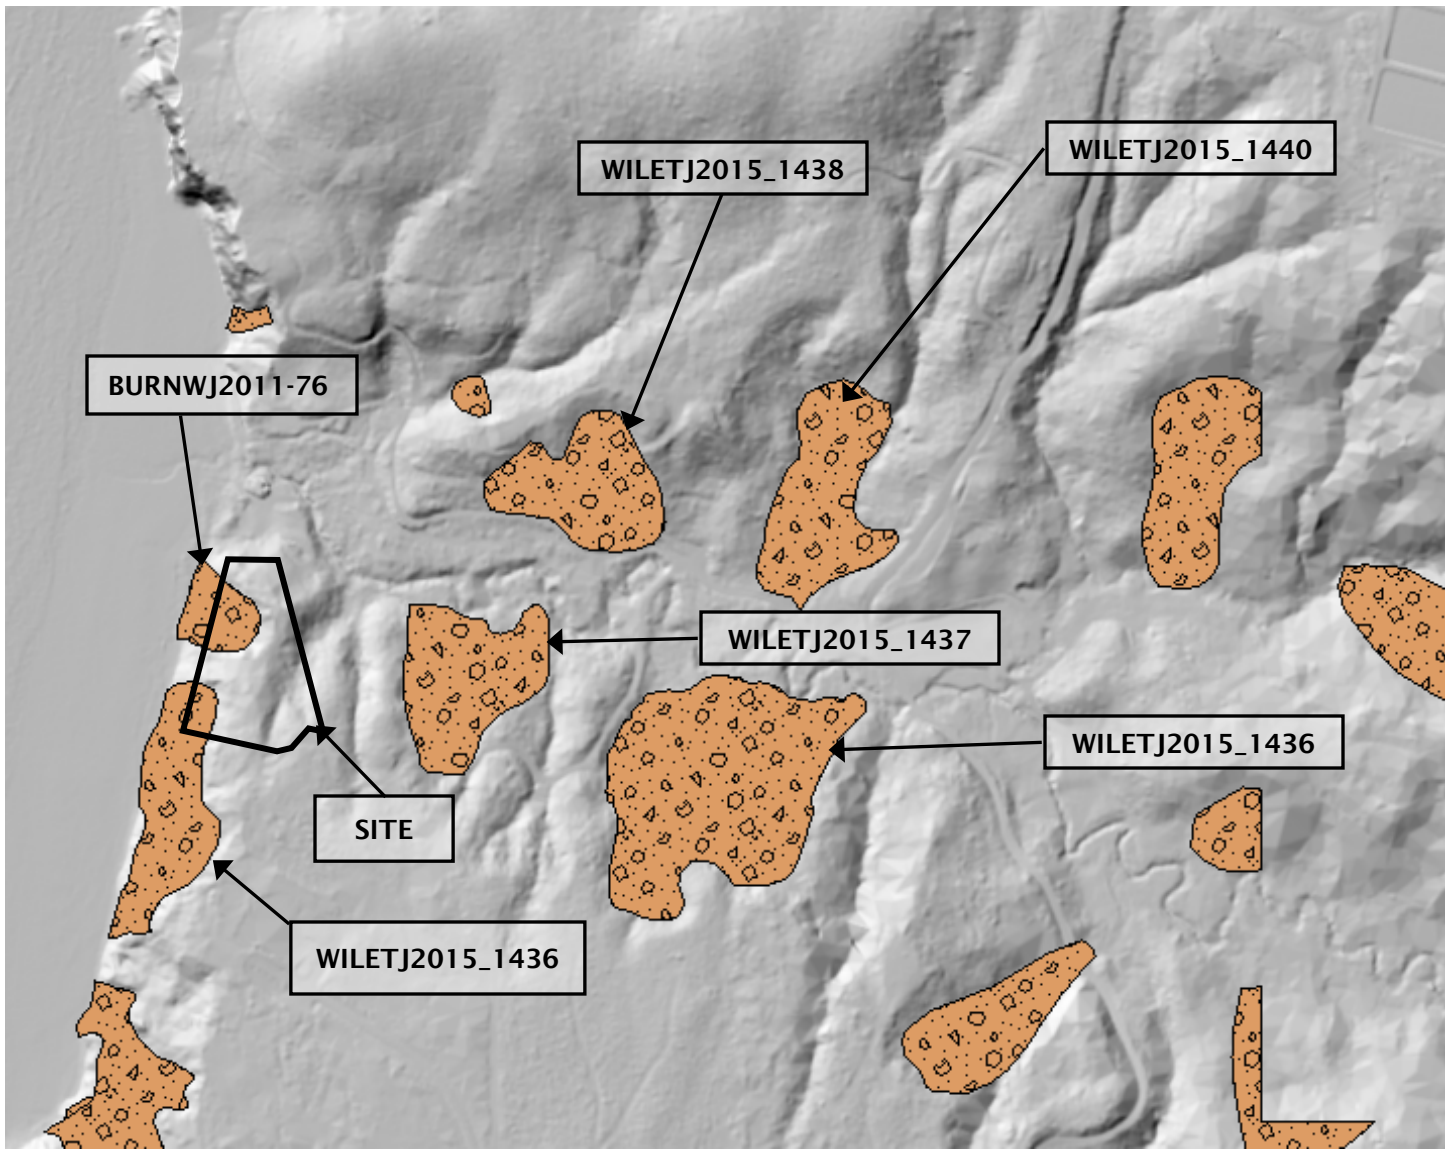
The site layout is shown in Figure 2. The landslides mapped by DOGAMI are shown in Figure 4. The LiDAR image of the site is provided in Figure 7.

1. BurnWJ2011-76⁶ is located with its toe along the Pacific shoreline. It extends into the northwest corner of the project site and the proposed putting green that is about 250 feet from the planned home.

The planned location for the new home is set back from the "Bluff/FEMA line established by Coos County sufficiently far that the risk of future large-scale and deep-seated ground movement that would damage the home is remote.

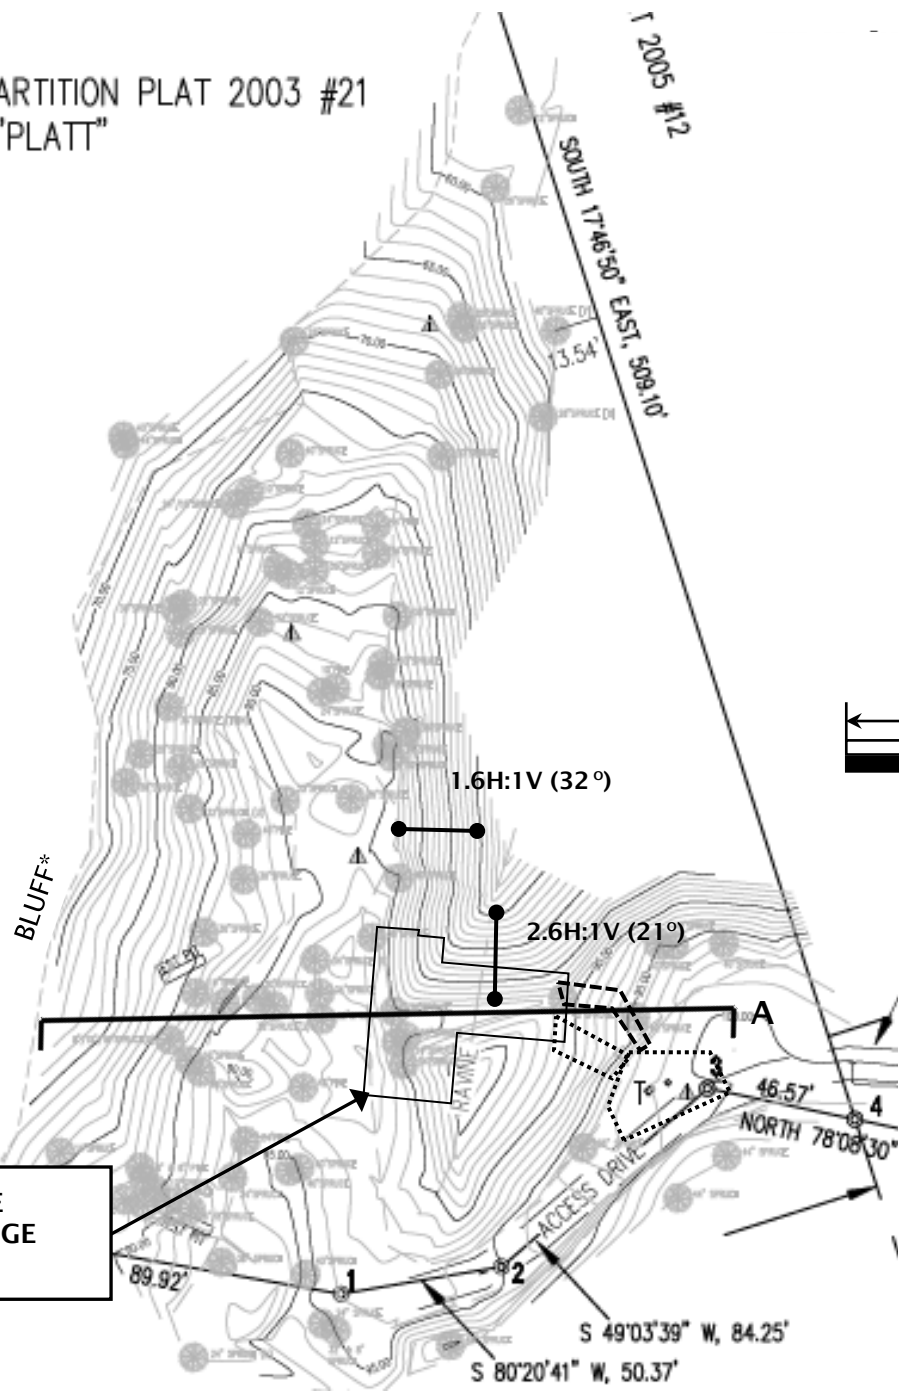
<p>PROJECT 1592</p>	<p>PLATT RESIDENCE AGATE LANE - BANDON</p>	
<p>2839 SE Milwaukie Avenue Portland, OR 97202</p>	<p>JAN 2022</p>	<p>SLOPE INCLINATIONS</p>	
	<p>Drawn By: tac</p>

On the project site, the dune forms a nearly flat ridgetop that is 30 to 70 feet wide at an elevation of about 140 feet above MSL. The dune slopes gently downward from the ridgetop toward the ocean at an inclination of about 3.6H:1V (Horizontal to Vertical) (15 degrees). The dune slopes moderately downward to the east and an inclination of about 2.6H:1V (21 degrees).

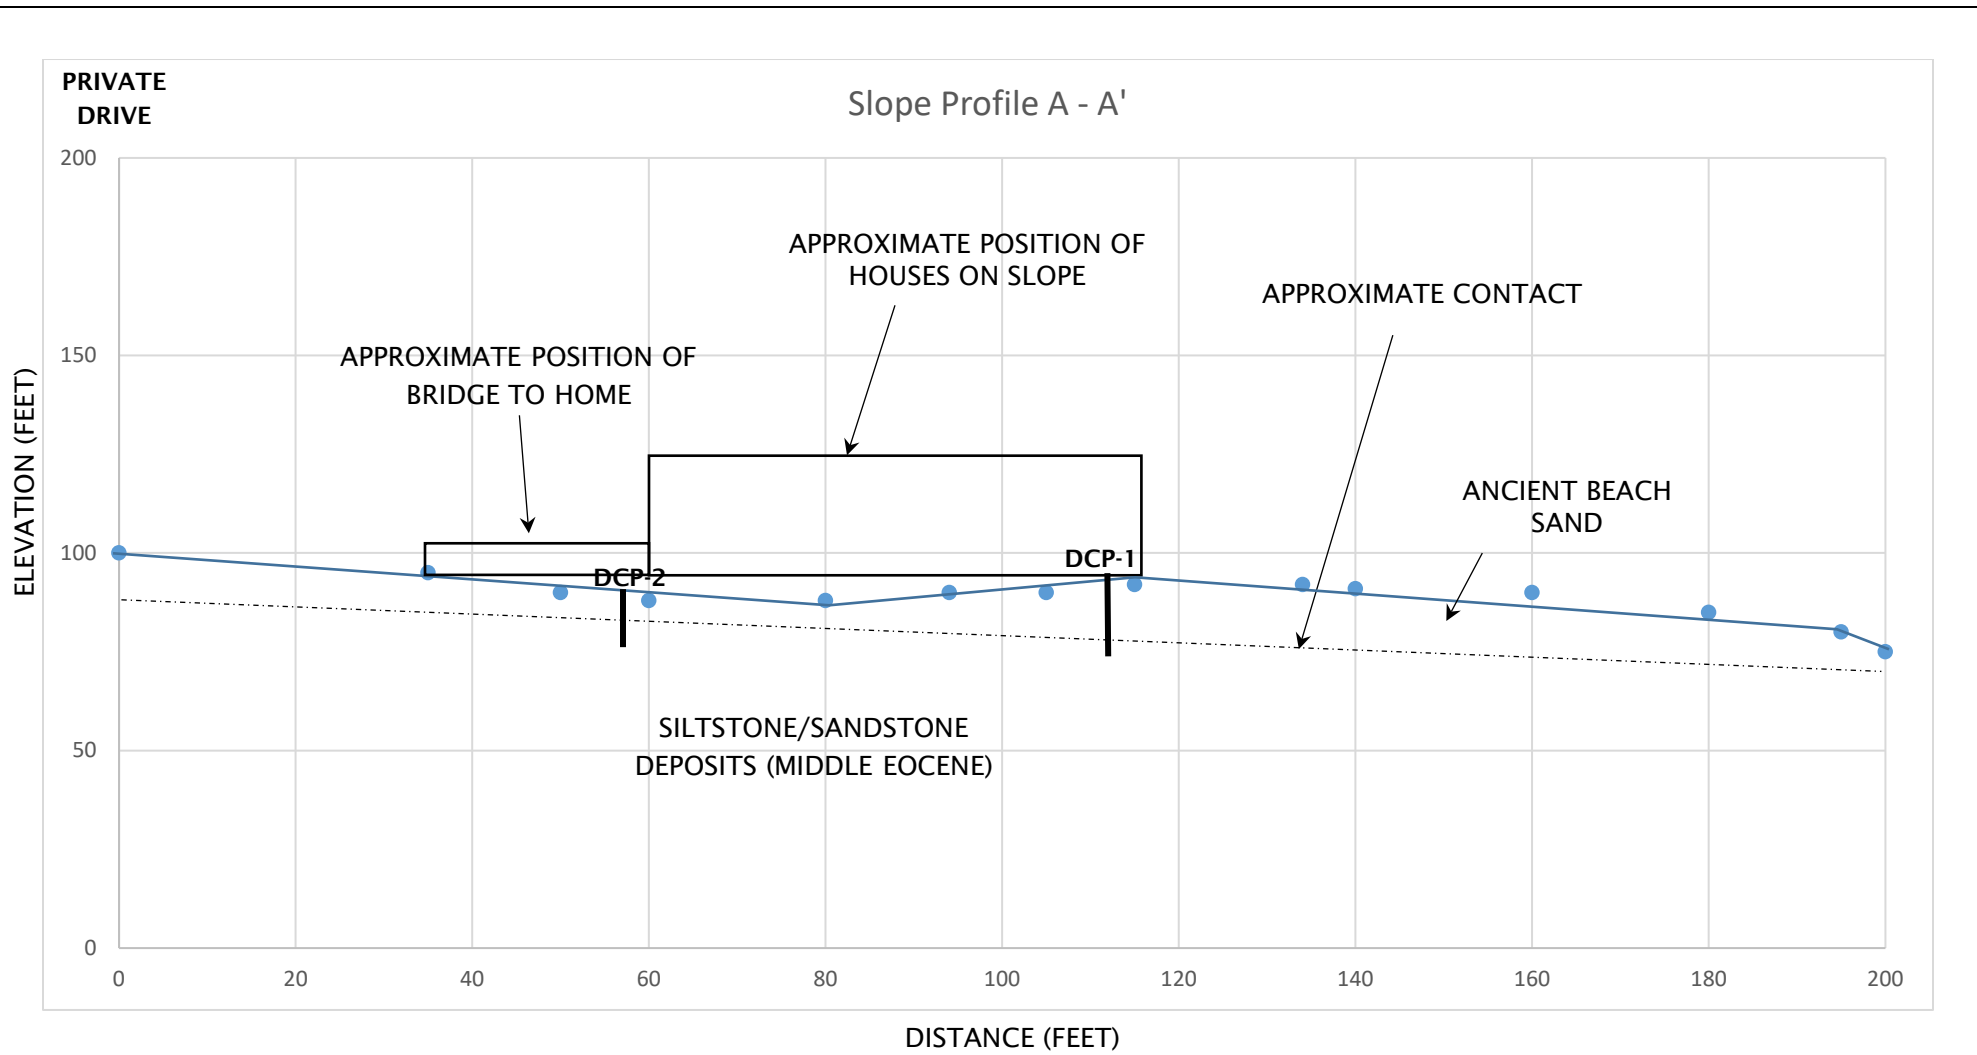
PROJECT 1592	PLATT RESIDENCE AGATE LANE - BANDON	
	2839 SE Milwaukie Avenue Portland, OR 97202	JAN 2022 Drawn By: tac	SLOPE PROFILE A - A'

Based on our understanding of the site topography and the results of our explorations, we generated an interpolated geologic profile, designated A-A', the location of which is shown in Figure 5. The interpolated soil and rock profile A-A' is shown in Figure 6.
