**Reconnaissance-Level
Geologic Hazard Assessment Report**

Proposed Development
Peppermill, LLC's Property
North of Sacchi Beach, Coos County, Oregon

June 24, 2024

Project No. 959-23013-01

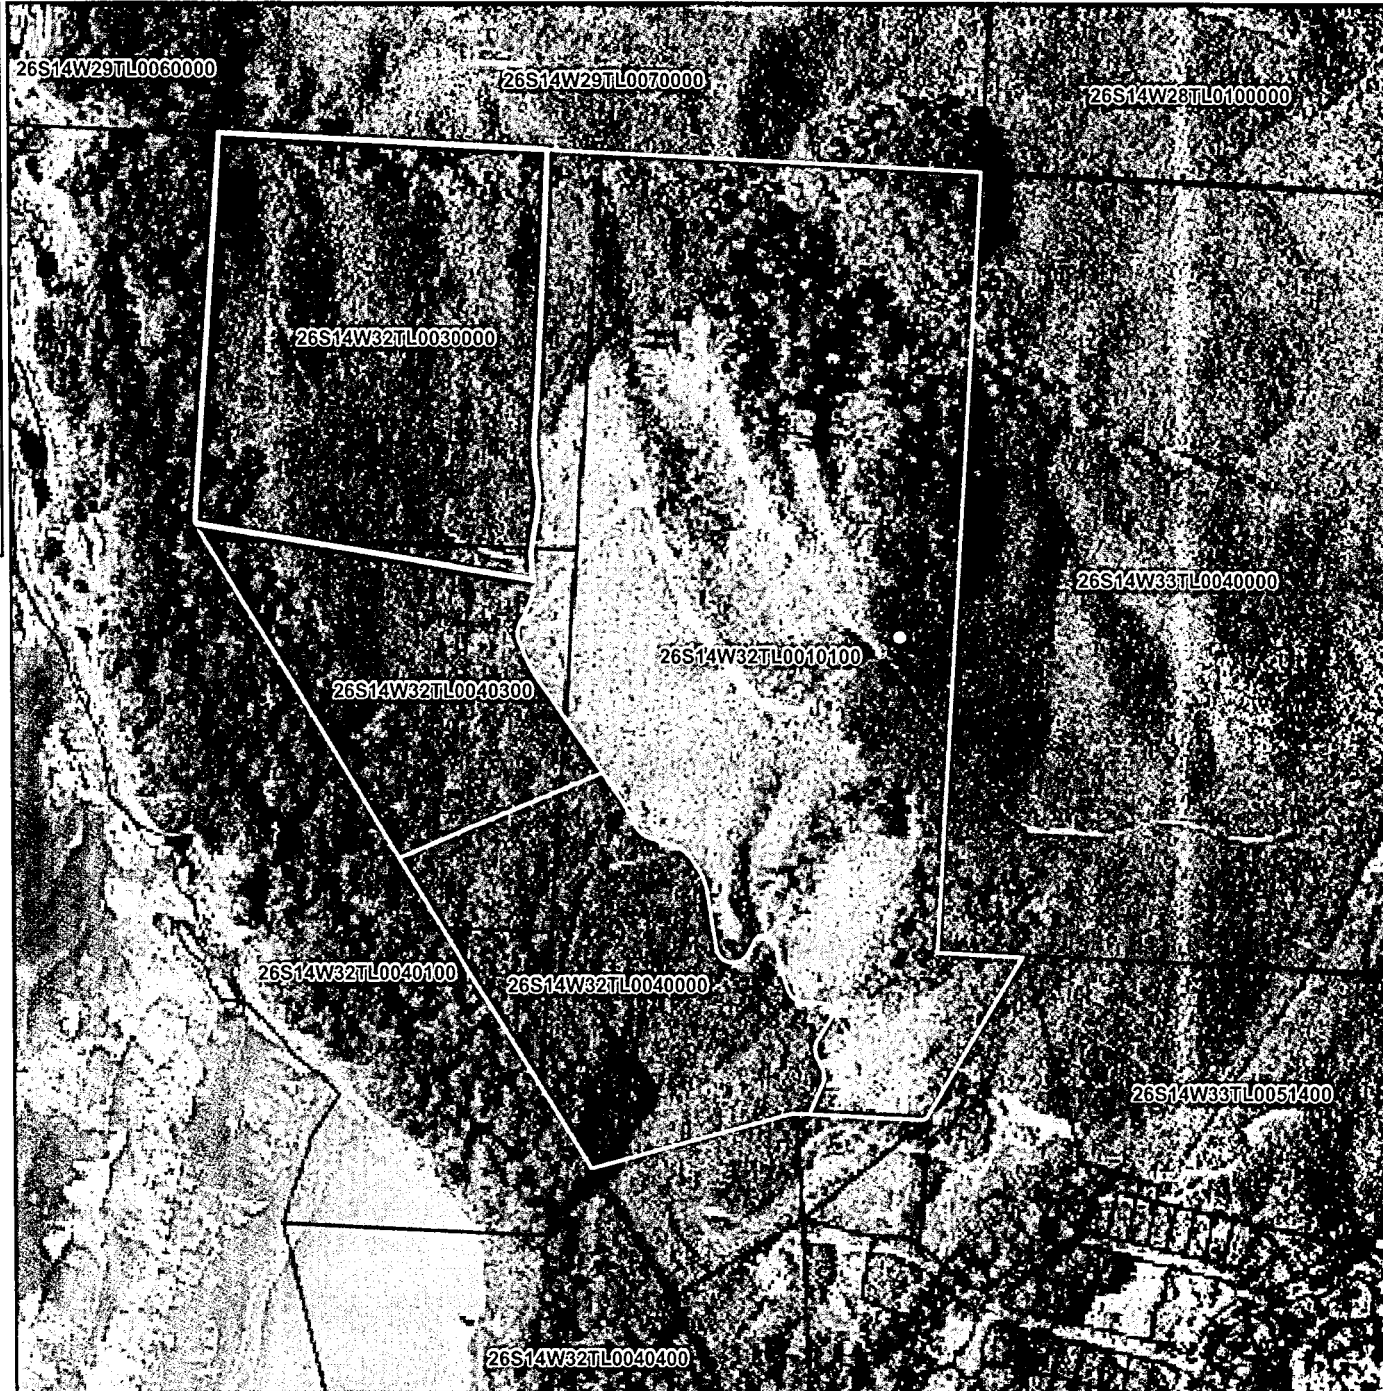
FIGURE 3
COOS COUNTY TAX LOT MAP
 PEPPERMILL, LLC'S PROPERTY
 NORTH OF SACCHI BEACH
 BANDON, OREGON

No ground water was encountered in the shallow hand auger borings (see Appendix B). Based on logging of the domestic water well on Tax Lot 101 (see Figure 3 and Appendix A), depth to ground water is likely over 40 feet bgs in the proposed development area.

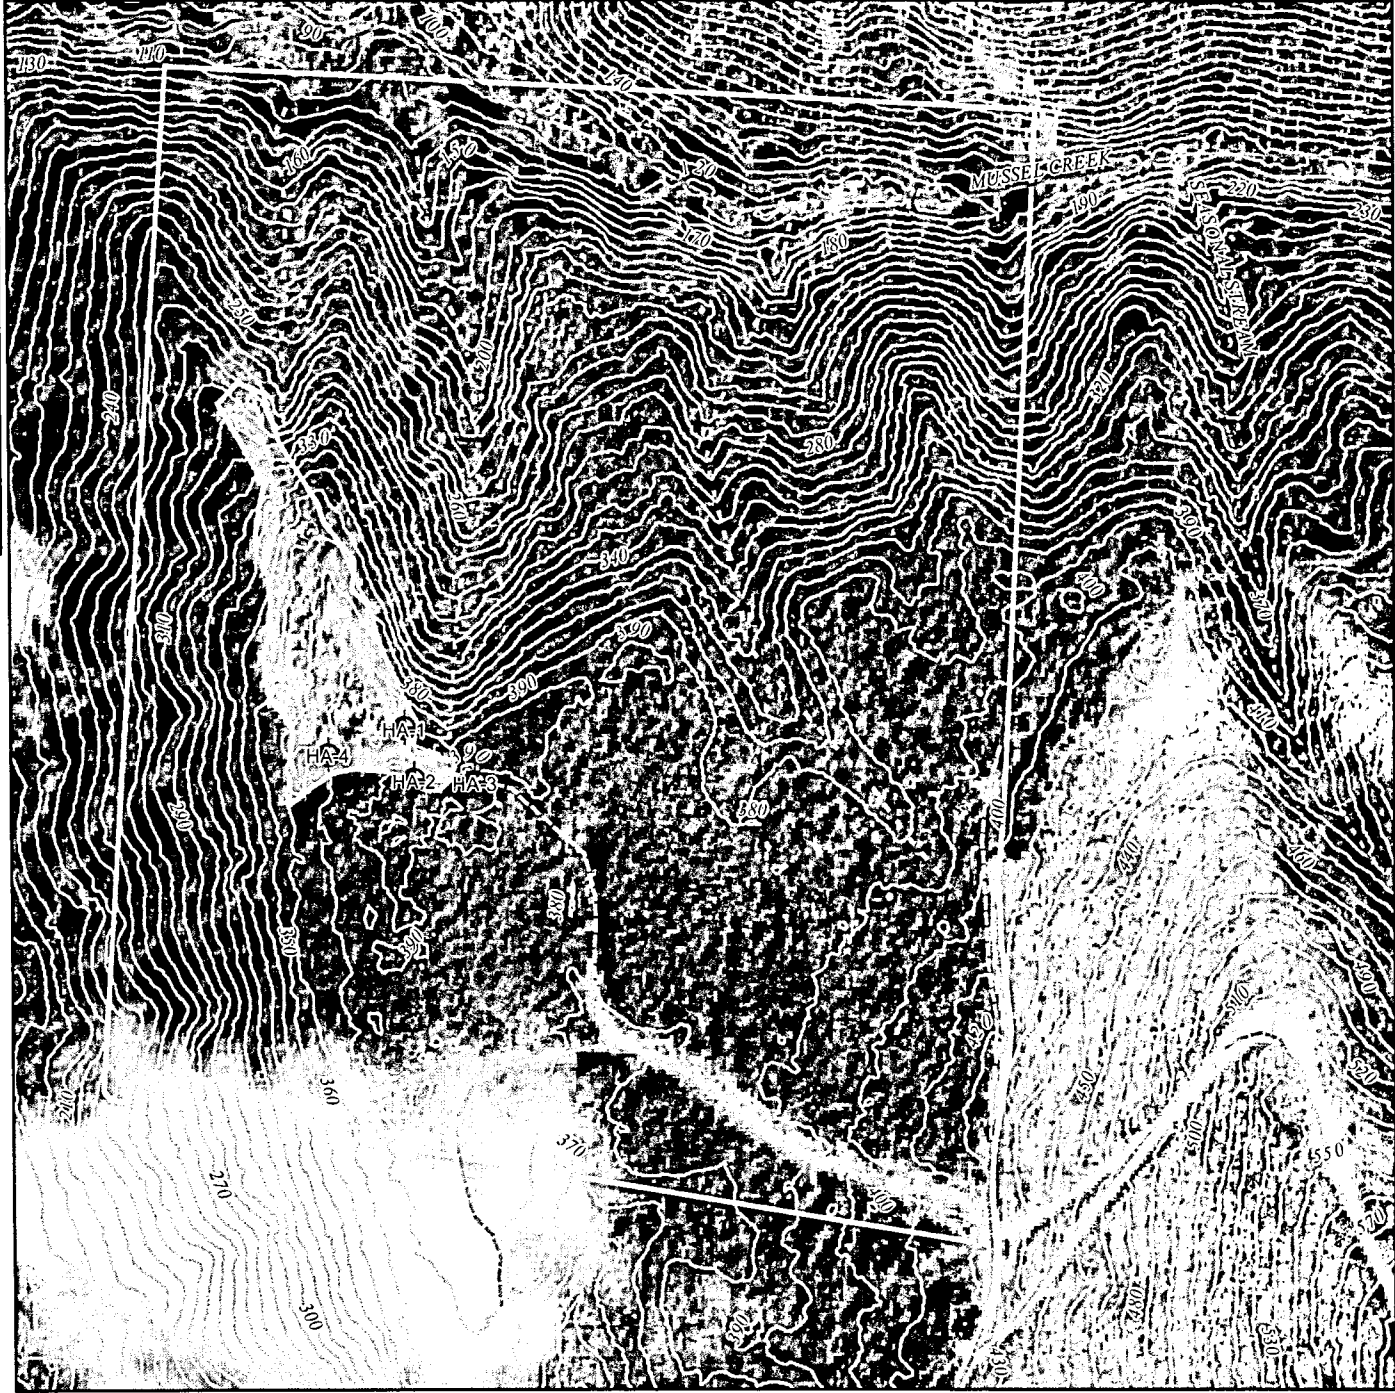
FIGURE 4
EXISTING SITE PLAN
 PEPPERMILL, LLC'S PROPERTY
 NORTH OF SACCHI BEACH
 BANDON, OREGON

The rectangular property has elevations that range from 420 feet NAVD 88 at the southeast corner of the property boundary to 100 feet NAVD88 at the northern property boundary along Mussel Creek (see Figure 4). Along the western portion of the site, the slopes are extremely steep and with over 160 feet of relief. To the north, three ephemeral drainage ravines trend down to Mussel Creek.

No seeps or other indicator of shallow ground water were observed near or around the proposed development area. North of the proposed area are three ephemeral drainages that flow (when discharging) into Mussel Creek (see Figures 4 and 5). At the time of our site investigation, we could not confirm water flowing in the streams due to the steep and densely vegetated terrain.

Much of the southeastern portion of the subject property is situated on relatively flat terrain with steep slopes and ravines in the north and west (see Figures 4 and 5). An existing access road on the property runs across the relatively flat terrain and then out to the cleared ridge line in central portion of the site (see Figure 4). The proposed development area is bound to the east and west with 35 percent slopes and to the north with 25 percent slopes.

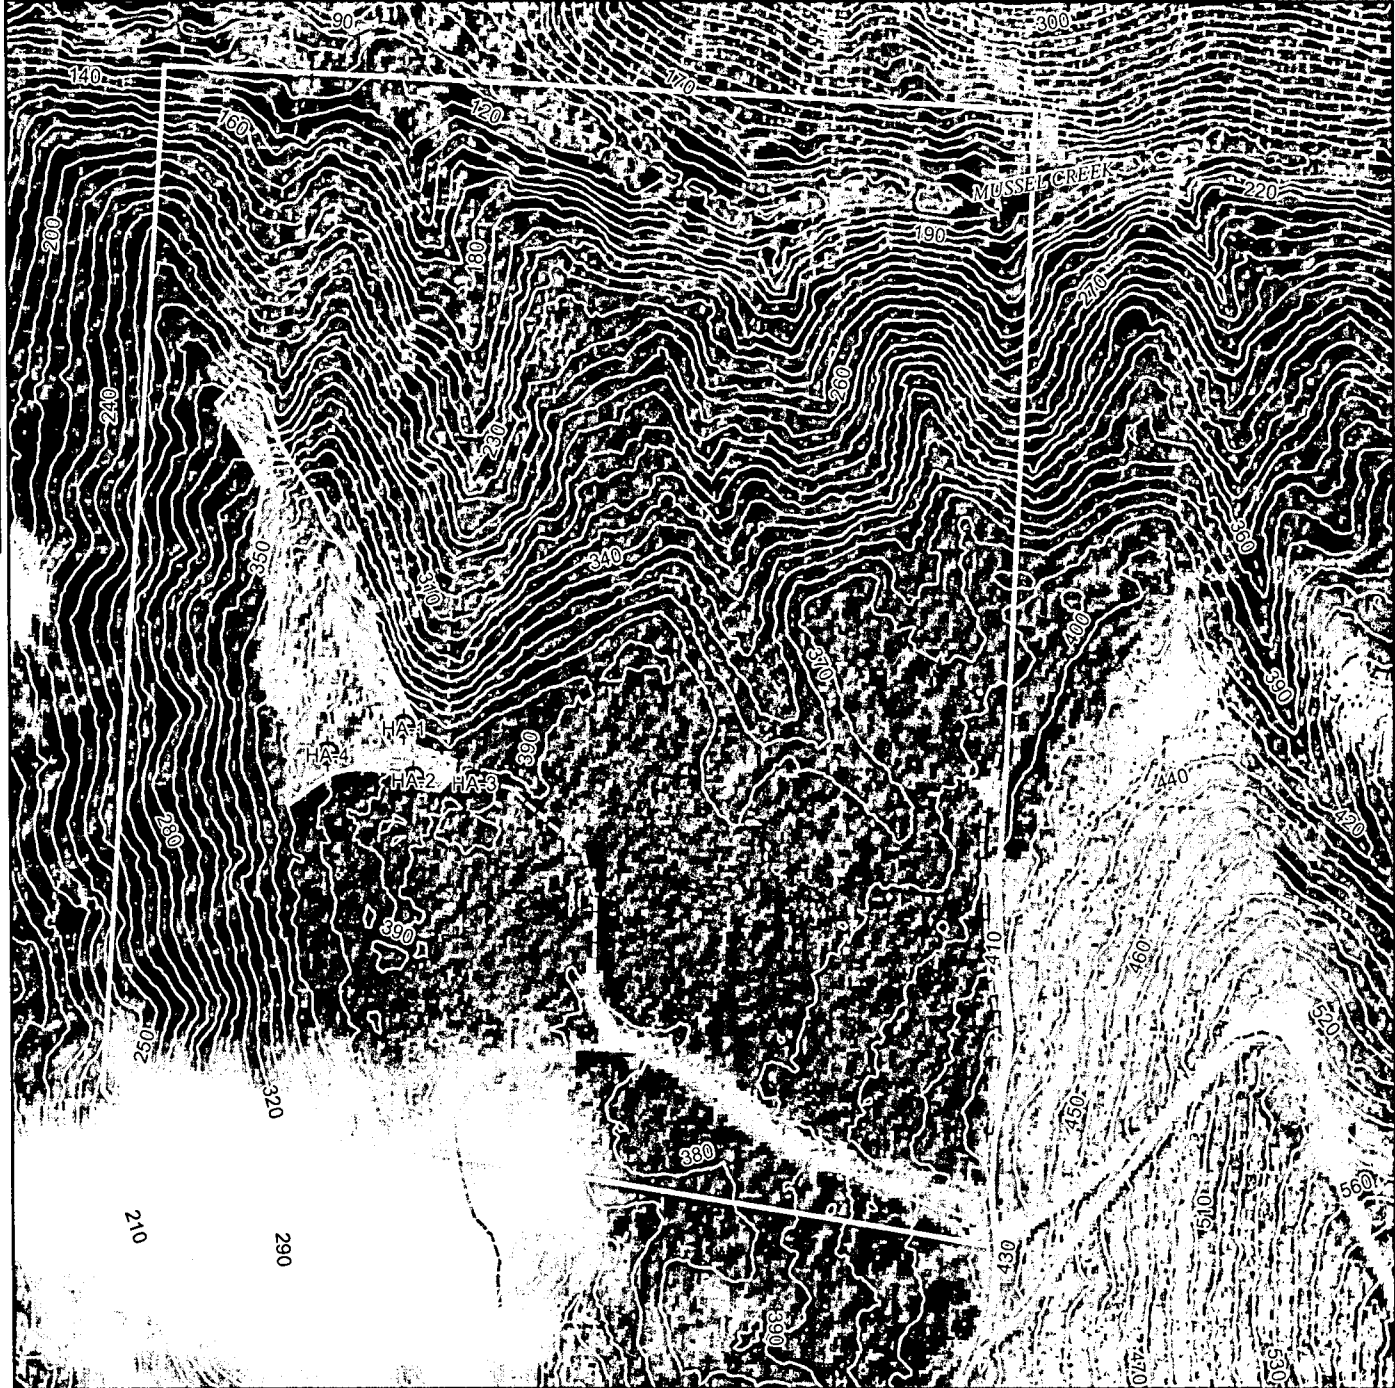
ENW understands the property owner cleared a portion of the site for future development (see Figure 5). The cleared area is in the west-central extent of the property and is along a prominent ridge line (see Figures 4 and 5). The existing access road enters the site at the southern end of the cleared area. The cleared area remains relatively flat along the east side of the ridge and slopes westward at about 24 percent (see Figures 4 and 5). There is a significant drainage to the east of the cleared area that flows to Mussel Creek at the north end of the property.

The proposed development area was cleared of trees and brush (see Figures 4 and 5). After clearing, the top of the ridge was left ungraded and slopes with the natural gradient of the ridge to the north, west, and east. (see Figures 5). At the time of our site visit, there were several slash piles, organic debris, and other deleterious material across the site. To the north and east of the cleared area are several ephemeral drainages that flow north into Mussel Creek, when discharging. In the northern portion of the property, Mussel Creek flows west into the ocean and is deeply incised into the underlying Coaleda Formation.
