RE: Winter Lake Phase III System Restoration and Maintenance Permit Application

Attachment A:
FIGURES AND PHOTOS

WINTER LAKE PHASE III

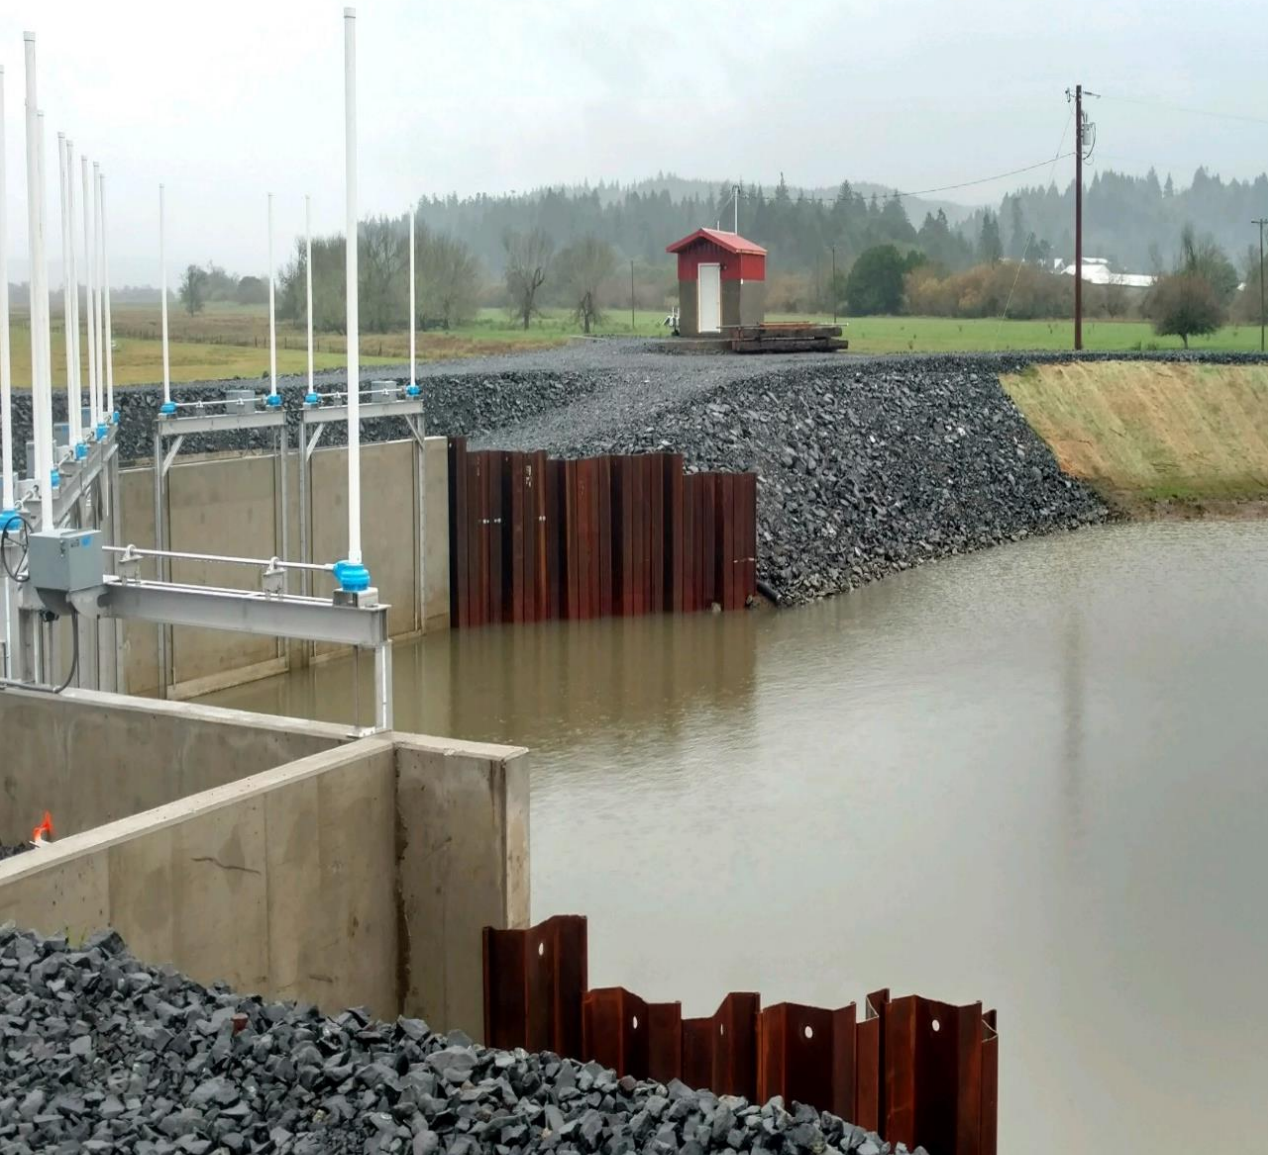
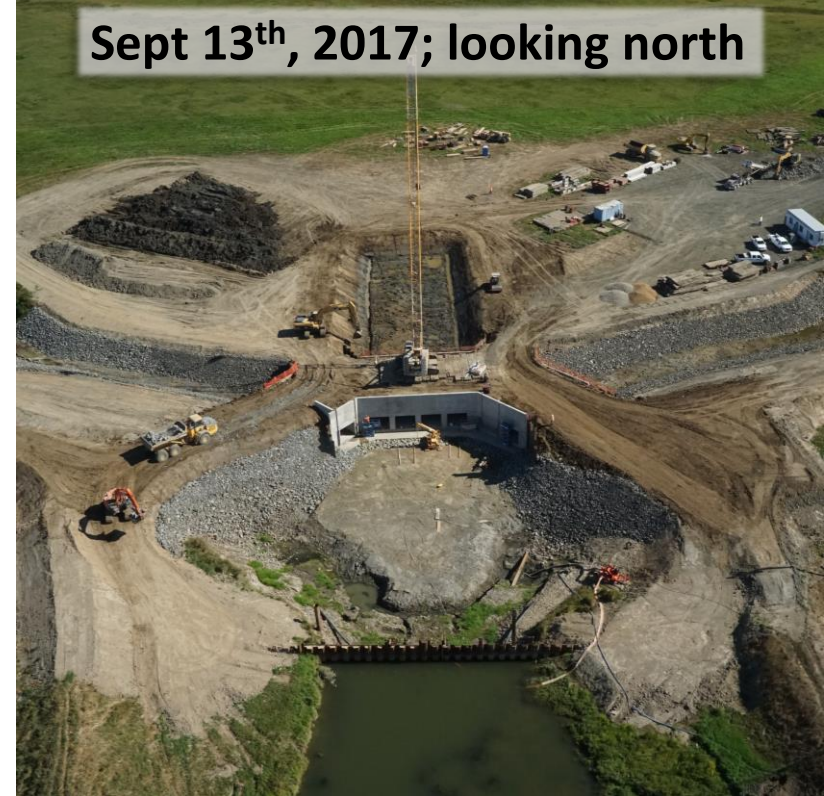
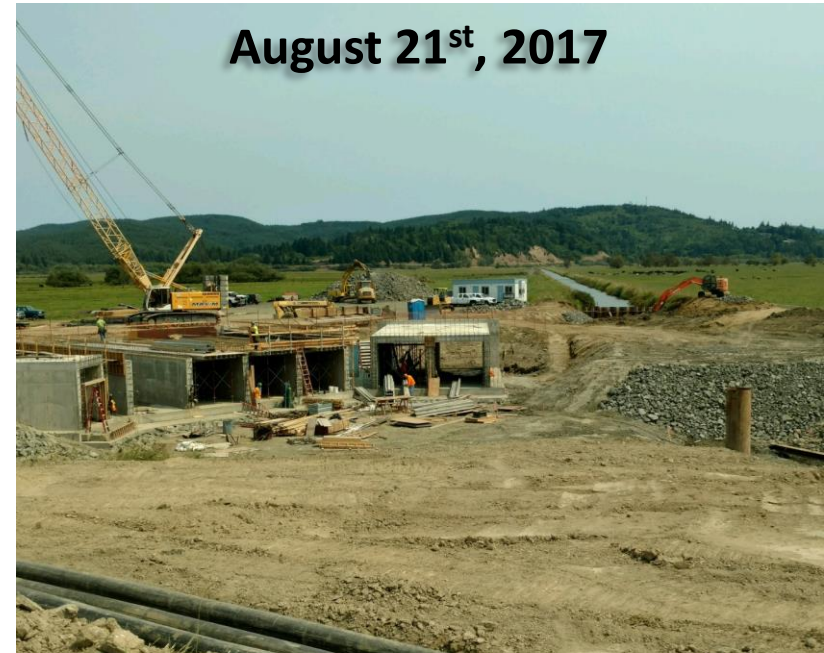
Figure 7. Winter Lake Phase I, CP3 Tidegate

Sept 13th, 2017; looking north

August 21st, 2017

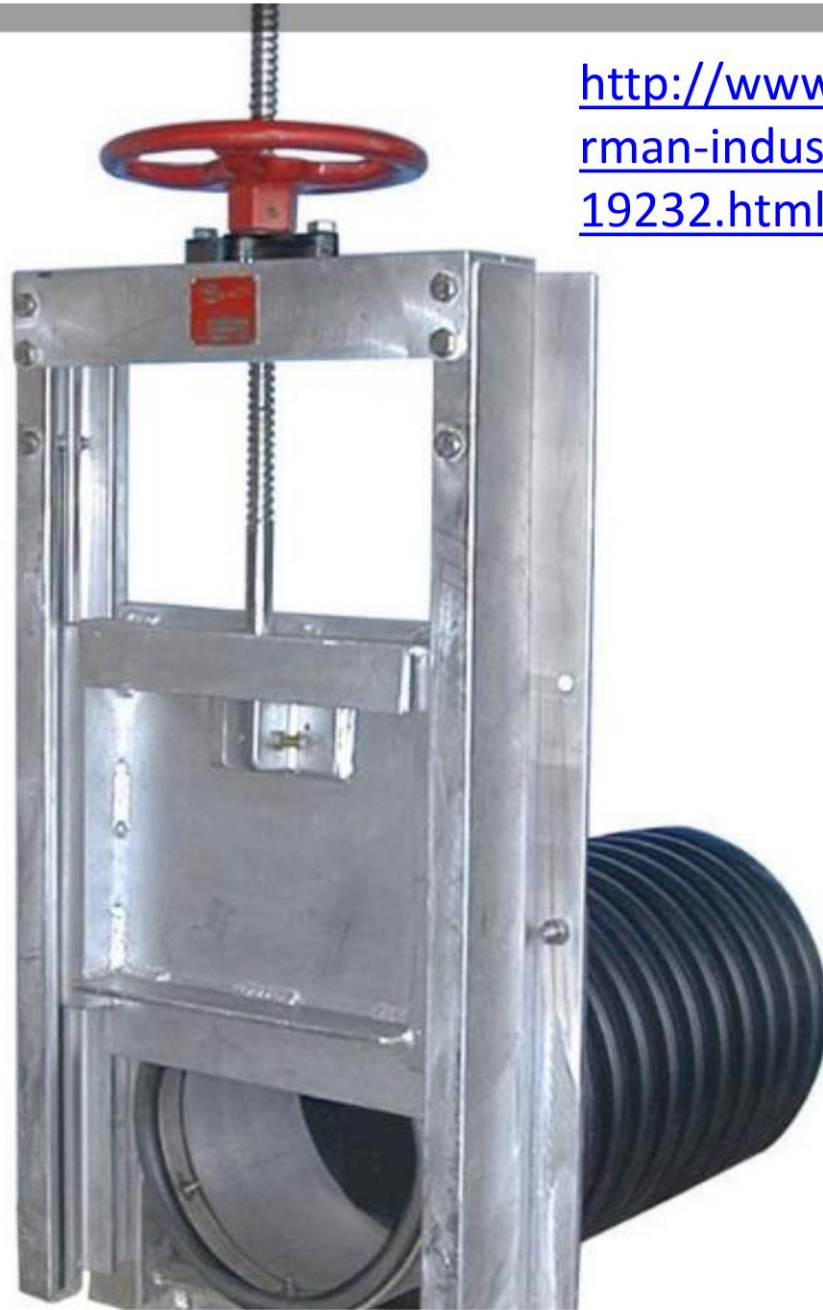
Figure 14. Aluminum Waterman Style gate

Aluminum Waterman Style Gate

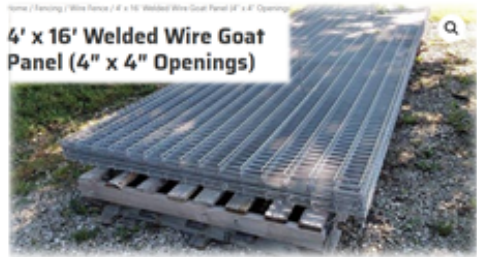
Planting Plots #1: Welded panels or wire; 4.0w x 20ft in length alternated on channel sides with 50ft spacing. Trees planted (cottonwood or ash) inside enclosure 8 total trees planted on six ft spacing. Planting plots are on large and medium channels that connect to main canals for first 500ft. **Note:** Welded panels or wire is needed with 4"x4" mesh to protect trees from livestock and beaver.

Expanded Plot View

Wooden or T-post

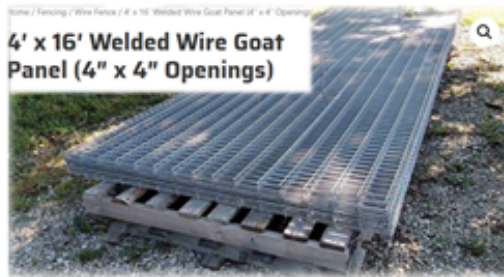
Planting Plots #2: Welded panels or wire; 4.0w x 10ft in length alternated on channel sides with 25ft spacing. Trees planted (cottonwood or ash) inside enclosure 8 total trees planted on six ft spacing. Planting plots are on large and medium channels that connect to main canals for first 500ft. **Note:** Welded wire is needed with 4"x4" mesh to protect trees from livestock and beaver.

Expanded Plot View

4' x 16' Welded Wire Goat Panel (4" x 4" Openings)

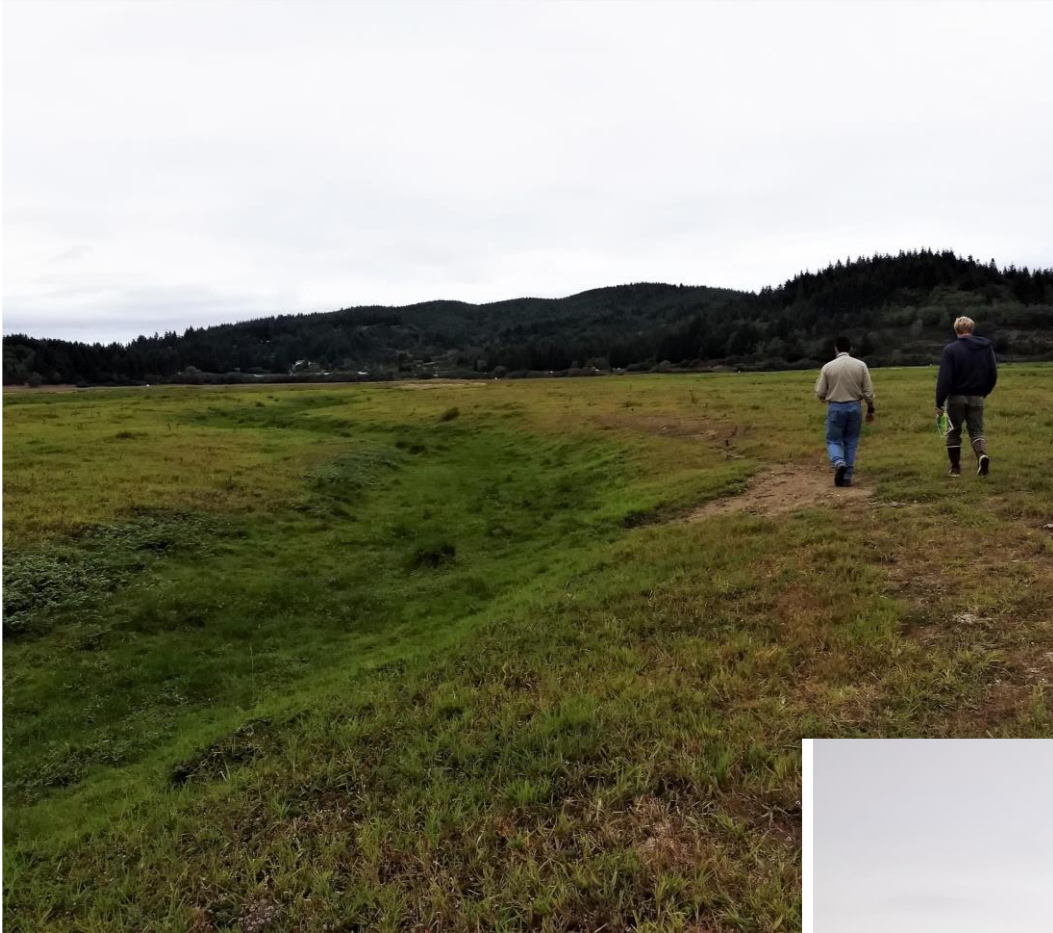
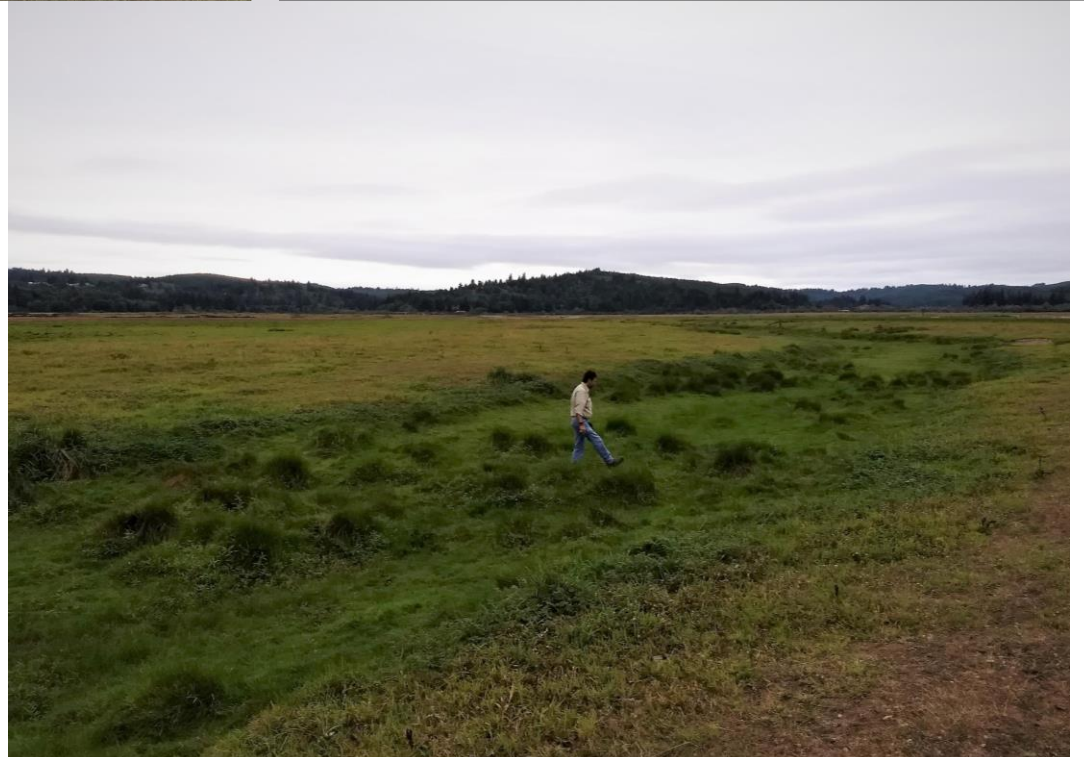
Figure 27. Photos of existing shallow swale channels

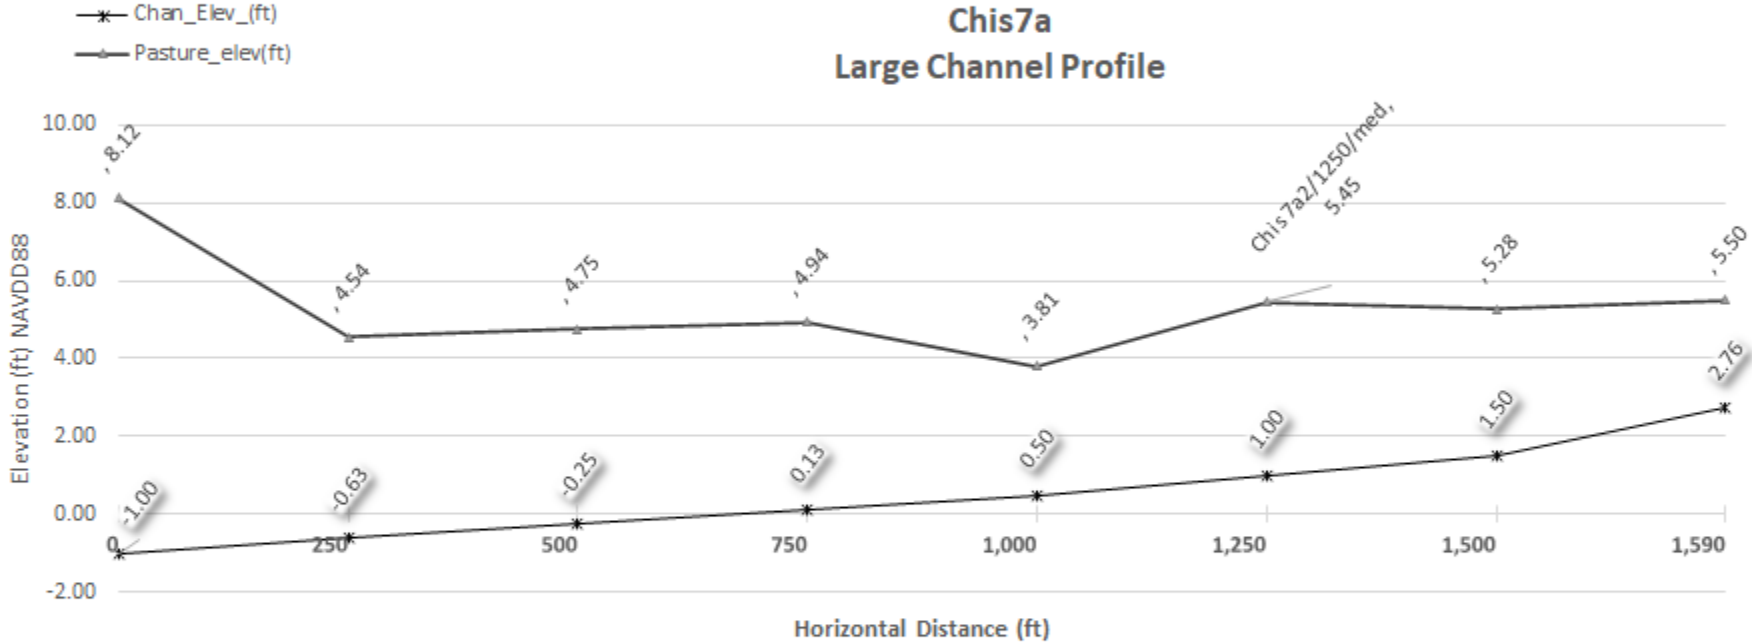
Sheet 11 of 26

Chis7a Large Channel Profile

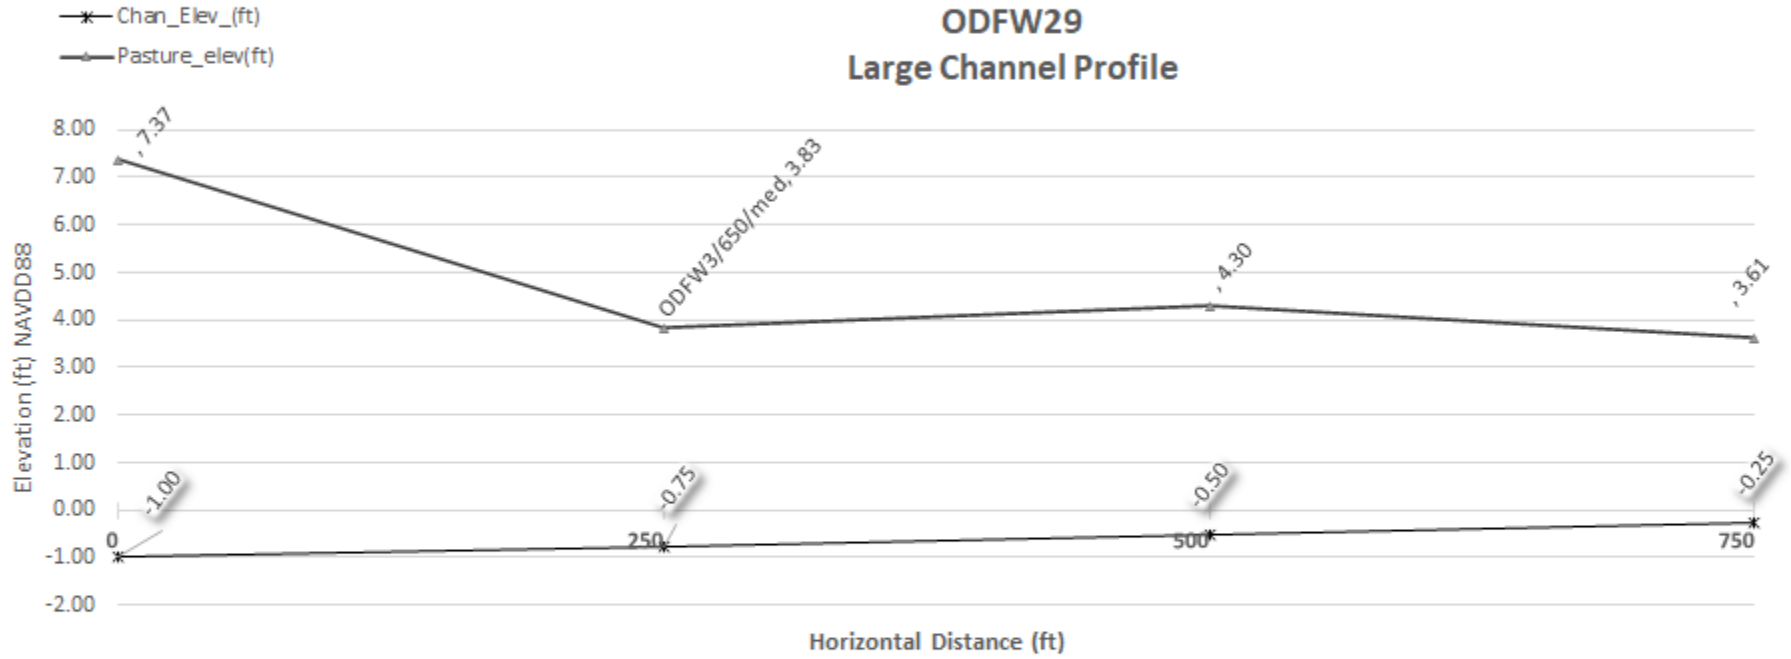
Sheet 16 of 26

ODFW29 Large Channel Profile

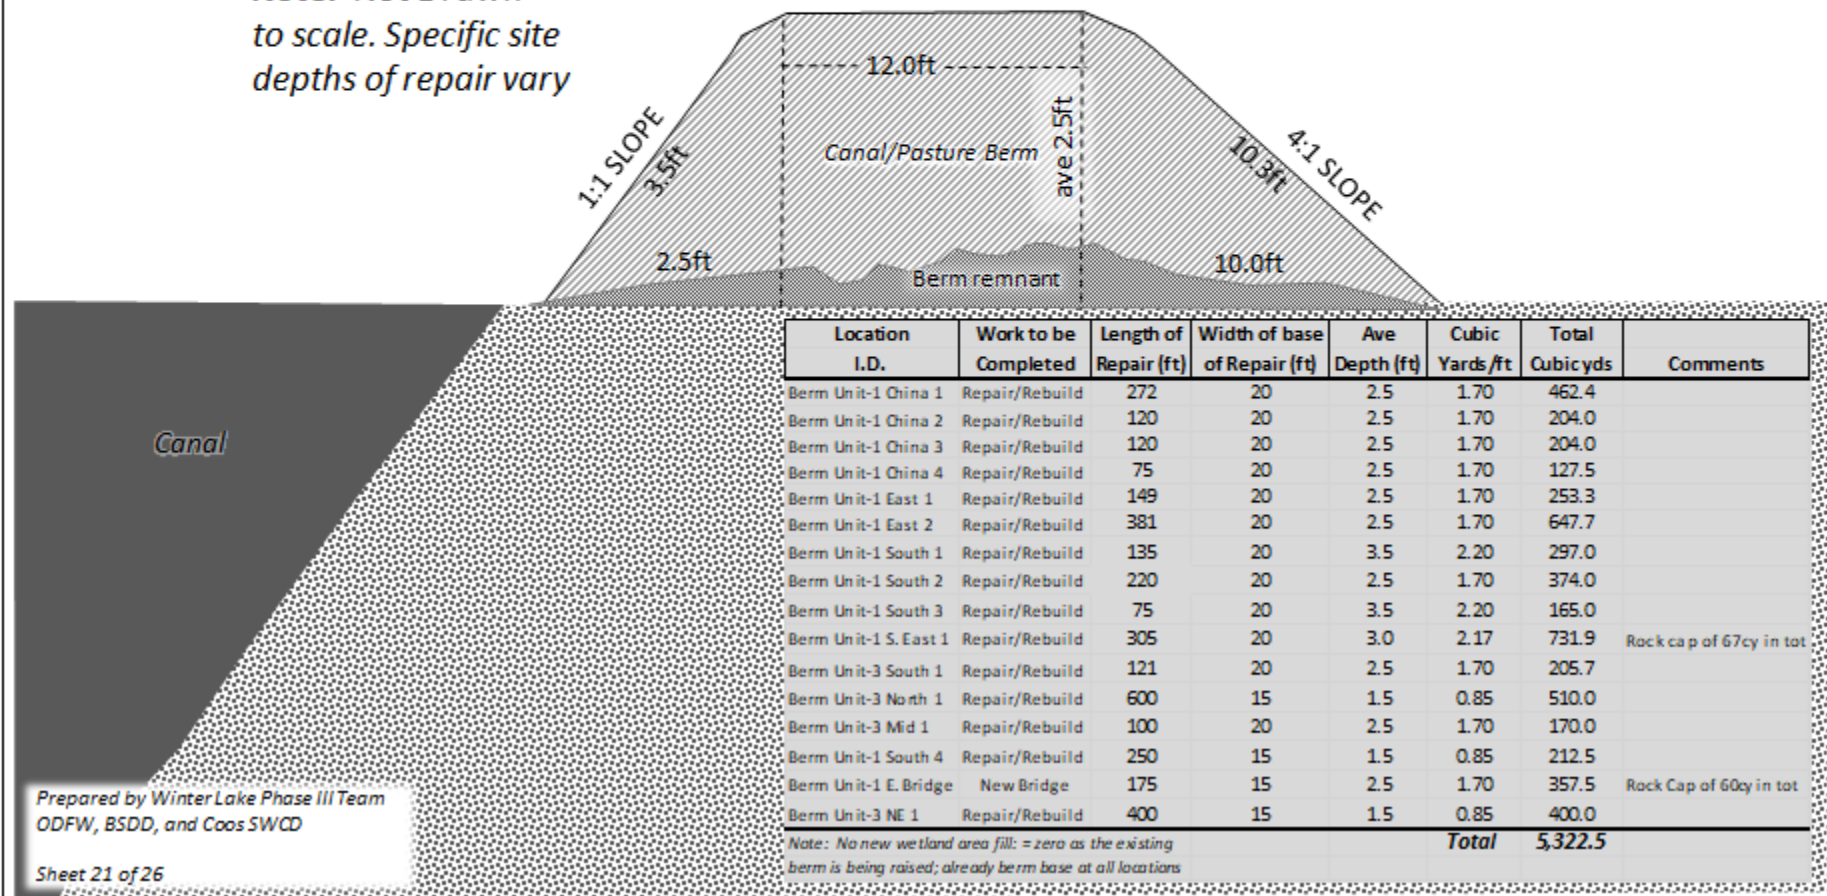
TYPICAL INTERIOR
PASTURE/CANAL BERM
REPAIR DESIGN

Note: Not Drawn
to scale. Specific site
depths of repair vary

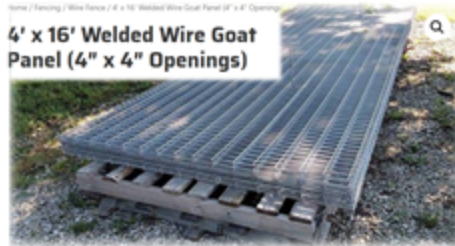
Expanded Plot View

Planting Plots #1: Welded panels or wire; 4.0w x 20ft in length alternated on channel sides with 50ft spacing. Trees planted (cottonwood or ash) inside enclosure 8 total trees planted on six ft spacing. Planting plots are on large and medium channels that connect to main canals for first 500ft. **Note:** Welded panels or wire is needed with 4"x4" mesh to protect trees from livestock and beaver.

4' x 16' Welded Wire Goat Panel (4" x 4" Openings)

Specification	Description
Mesh:	2 in. x 4 in.
Length:	100 ft.
Height:	60 in

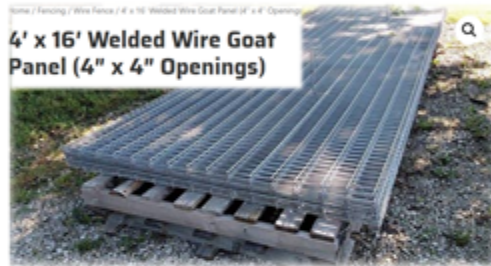
Large/Medium Connecting Channel Skip Planting Concepts Option #2

Planting Plots #2: Welded panels or wire; 4.0w x 10ft in length alternated on channel sides with 25ft spacing. Trees planted (cottonwood or ash) inside enclosure 8 total trees planted on six ft spacing. Planting plots are on large and medium channels that connect to main canals for first 500ft. **Note:** Welded wire is needed with 4"x4" mesh to protect trees from livestock and beaver.

Specification	Description
Mesh:	2 in. x 4 in.
Length:	100 ft.
Height:	60 in

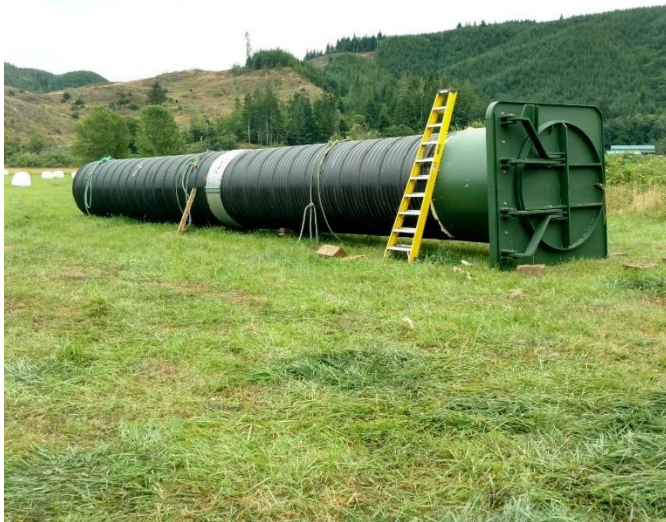
Figure 3. Typical side-hinged aluminum tidegate mounted on 6.0ft CMP.

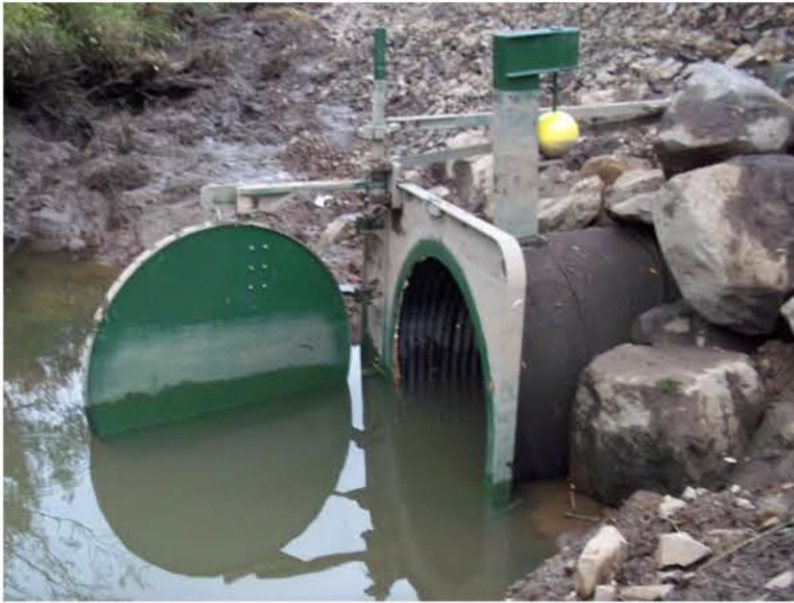
Figure 4. Side-hinged aluminum tidegate door in working location.
